## SERVICE BULLETIN

**NUMBER:** 11-205-25

**DATE:** 01/16/25

**SUBJECT:** DTC P1449 EVAP System Clog Detected /  
Repair Procedure

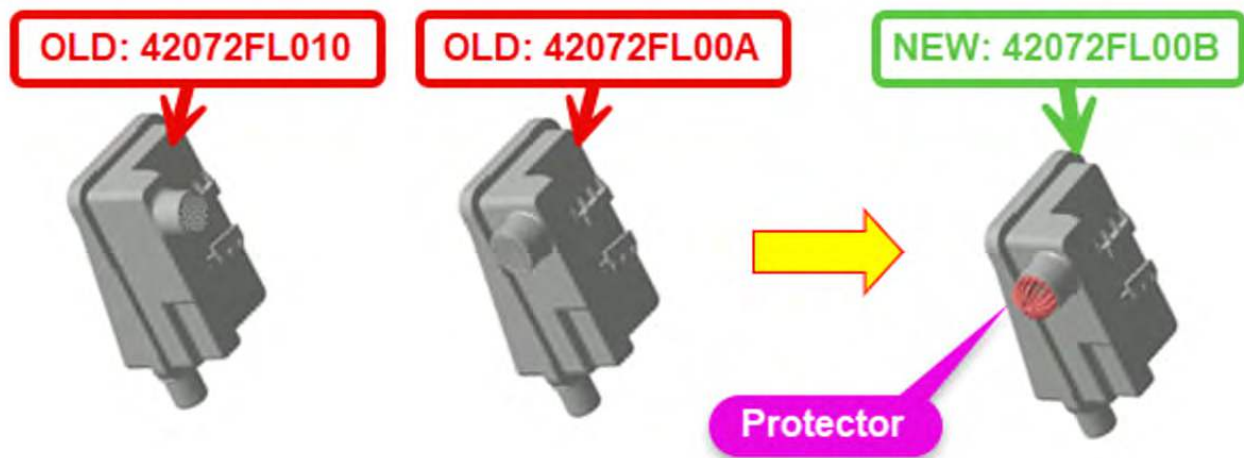
### DRAIN FILTER / DESCRIPTION OF DESIGN CHANGE:

This bulletin announces the repair procedures to be followed when DTC P1449 (EVAP System Clog Detected) is detected by the Engine Control Module (ECM). New drain filter assemblies have been developed with an added protector to prevent debris build up. For some models, reprogramming and an additional mud guard will require replacement along with the drain filter. If DTC P1449 is found to be detected by the ECM, follow the service procedure outlined in this bulletin.

**STEP 1:** Replace the drain filter as per the applicable Service Manual. Refer to STIS: Engine > EMISSIONCONTROL (AUX. EMISSION CONTRL DEVICES) > Drain Filter

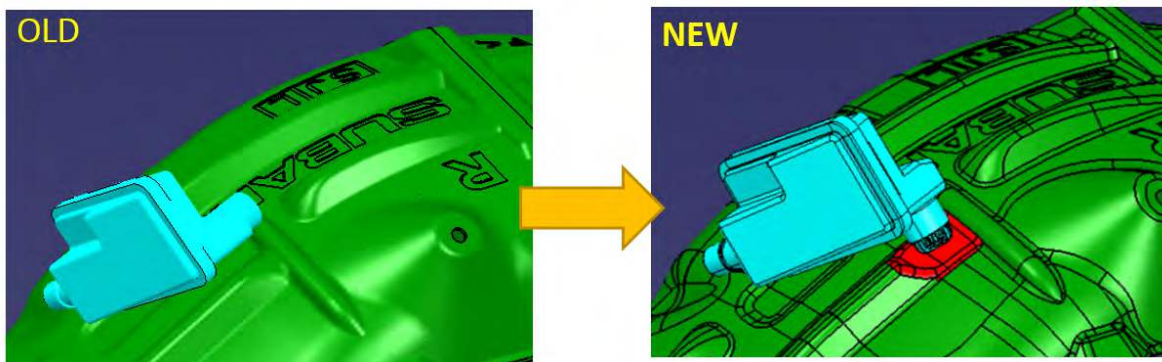
### FORESTER

**IMPORTANT:** Mud guard replacement is **ONLY** required on Forester and WRX models.

**STEP 1:** Replace the drain filter and right rear mud guard as per the applicable Service Manual. Refer to STIS: Engine > EMISSIONCONTROL (AUX. EMISSION CONTRL DEVICES) > Drain Filter
