# Technical Service Bulletin

## 93 e-tron GE various warning messages in the cluster, electric motor leaking P0AA600

93 25 52 2073858/6 January 23, 2025. Supersedes Technical Service Bulletin Group 93 number 24-46 dated December 19, 2024 for reasons listed below.

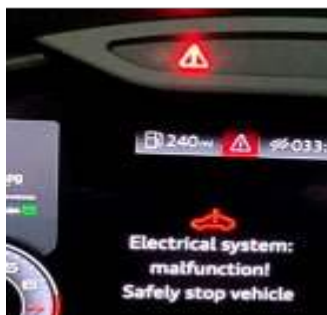
- A Drive System/Electrical System Malfunction message (Figure 1) appears in the in the instrument cluster; the warning may not be present at the time of inspection.

**Figure 1.** Warning lamp associated with message.

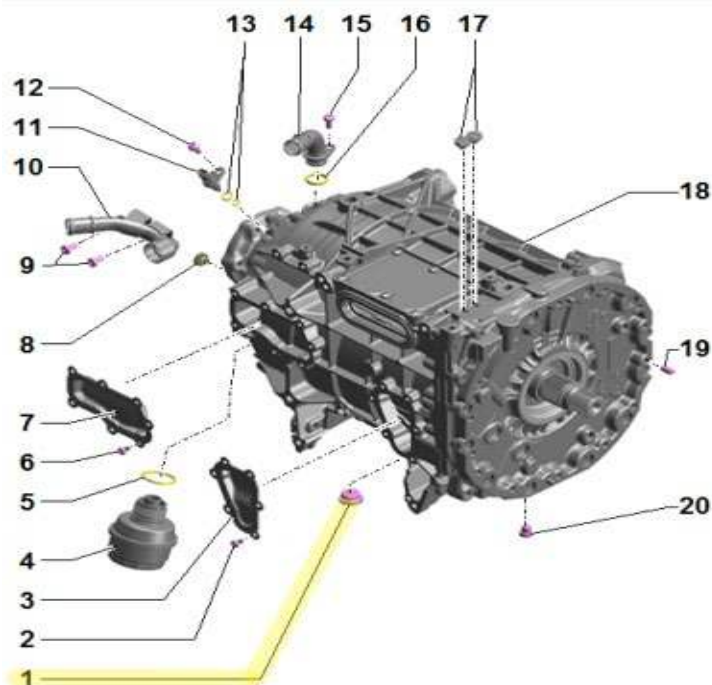
**Rear axle (Figure 2):**

Drip container is overflowing:

Coolant leaking from active chamber.

Drip container is empty:

Coolant leaking from active chamber, particularly on vehicles with low mileage.

**Figure 2:** (1) Drain plug.

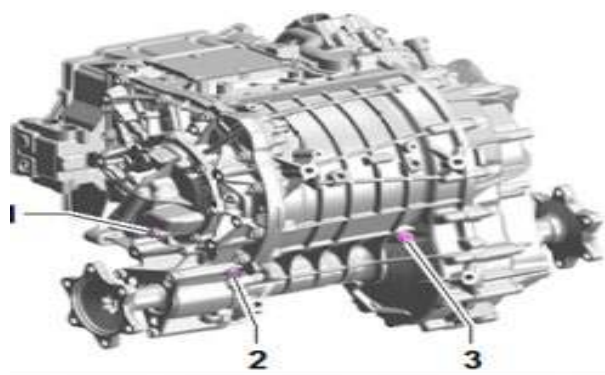
## **Front axle (Figure 3):**

Coolant leaking from active chamber.

**Figure 3:** 1) *Resolver cover:* A few milliliters of coolant leakage is not an issue from a technical perspective. 2) *Active chamber:* No coolant may escape from the bores.

**The power electronics must not be replaced if the electric drive motor is leaking.**
