# Technical Service Bulletin

## 01 MIL on - DTC: U060B00 stored in engine control unit

01 25 53 2074392/2 January 30, 2025. Supersedes Technical Service Bulletin Group 01 number 24-29 dated July 3, 2024 for reasons listed below.

| Model(s) | Year | VIN Range | Vehicle-Specific Equipment |
|---|---|---|---|
| Q5 | 2022 – 2025 | All | Not Applicable |

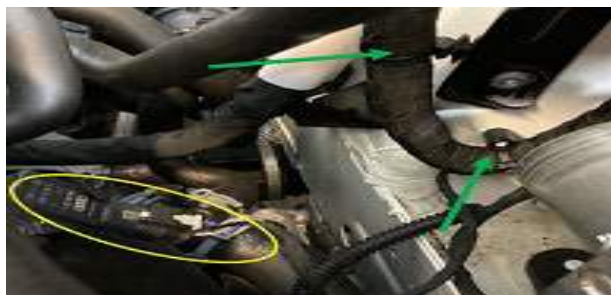
**Figure 1:** G31 and connector

Under certain conditions, vibrations may cause the wiring on electrical connector T3y to break.

Check wiring on electrical connector T3y for charge pressure sender -G31- for damage (see yellow circle on figure 1).

Disconnect electrical connector T91 on the engine control unit and loosen the wiring harness at the two mounting points (green arrows in Figure 1) to gain better access.

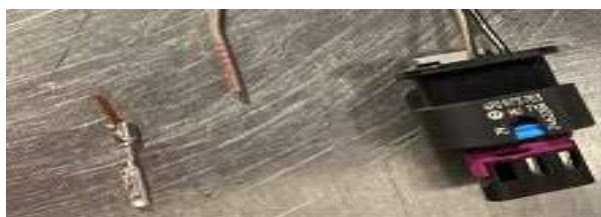
**Figure 2:** Wire damaged inside G31 connector

The damage may only be noticeable after de-pinning the connector or removing the harness tape.
