| <b>HYUNDAI</b><br><b>Technical Service Bulletin</b> | GROUP<br><b>FUEL SYSTEMS</b> | NUMBER<br><b>25-FL-002H</b> |
| <b>SUBJECT:</b> HIGH PRESSURE FUEL PUMP REPLACEMENT<br>(WARRANTY EXTENSION Z04) | | |

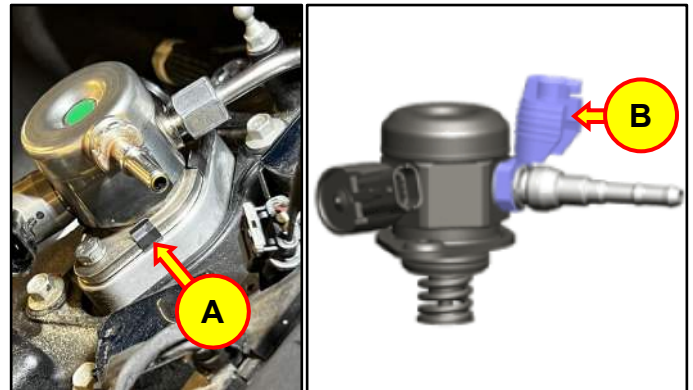
Be sure to transfer the shim-type metal pump gasket (A) and the low pressure fuel hose quick connector clamp (B) (if equipped) over to the new High Pressure Fuel Pump.

4. Record all radio presets and disconnect the battery negative (–) terminal.
5. Refer to the shop manual to remove the high pressure pipe and high pressure fuel pump.
  - **Engine Control / Fuel System > Fuel Delivery System > High Pressure Fuel Pump**
6. Refer to the shop manual to complete the installation of the new high pressure fuel pump, the new high pressure pipe, and all related parts.

7. Tighten the high pressure fuel components to the following specifications:
