## Technical Service Bulletin

**GROUP****FUEL SYSTEMS****NUMBER****25-FL-002G****DATE****FEBRUARY 2025****MODEL(S)****G70 (IK)****SUBJECT:**

HIGH PRESSURE FUEL PUMP REPLACEMENT  
(WARRANTY EXTENSION Z05G)

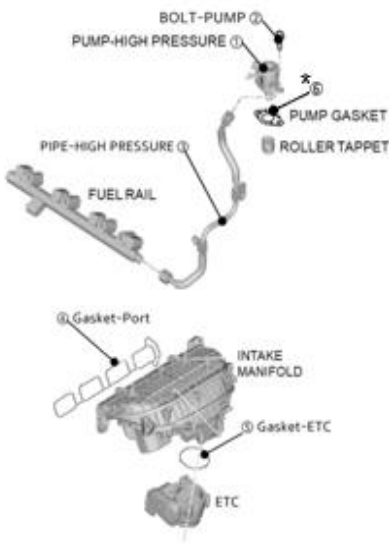
**Description:** Certain 2019-2023MY G70 (IK) vehicles are equipped with high pressure fuel pump (HPFP) assemblies that have fuel control valves (FCV) that could allow excess fuel to enter the fuel pump due to gradual wear of the FCV plunger. An air/fuel mixture that runs too “rich” may result in a reduction or loss of motive power at low speeds. The vehicle will also have Diagnostic Trouble Code (DTC) P0088.

| Model | Part Name / Part Number | Figure | Remarks |
|---|---|---|---|
| G70<br>(IK) | Pump – High Pressure Kit<br><br>35399-2C333QQH | | Pump – High Pressure<br>35320-2CTB1 (Figure 1: QTY 1) |
| | | | Bolt – Pump<br>11235-06226K (Figure 2: QTY 2) |
| | | | Pipe – High Pressure<br>35305-2CTA0 (Figure 3: QTY 1) |
| | | | Gasket – Port<br>28312-2CTA0 (Figure 4: QTY 1) |
| | | | Gasket – ETC<br>28313-2CTA0 (Figure 5: QTY 1) |
| | | | *Pump Gasket<br>(Figure 6: Transfer from old and reuse. <b>NOT</b> included in kit.) |

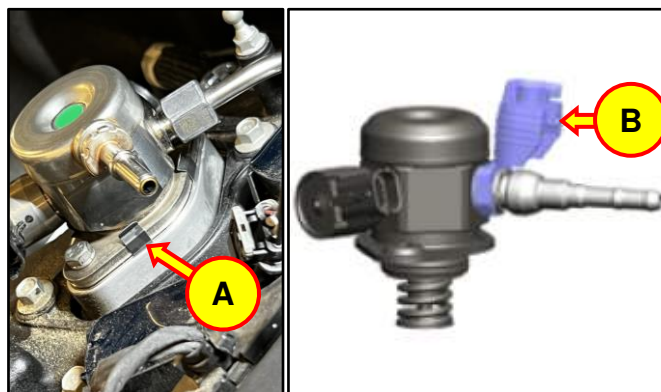
Be sure to transfer the shim-type metal pump gasket (A) and the low pressure fuel hose quick connector clamp (B) (if equipped) over to the new High Pressure Fuel Pump.

8. Tighten the high pressure fuel components to the following specifications:
