# Service Bulletin

Bulletin No.: PIE0815

**Subject:** Engineering Information – Service Engine Soon (SES) Lamp Illuminated on Driver Information Center (DIC), Suspect Non-OE Catalytic Converters and/or Exhaust Systems, DTCs P013F, P014A, P014B and/or P013E Set

| Brand: | Model: | Model Year: | | VIN Breakpoint: | | Engine: | Transmission: |
|---|---|---|---|---|---|---|---|
| Chevrolet | Corvette | 2023 | 2024 | — | — | 5.5L (RPO LT6) | All |

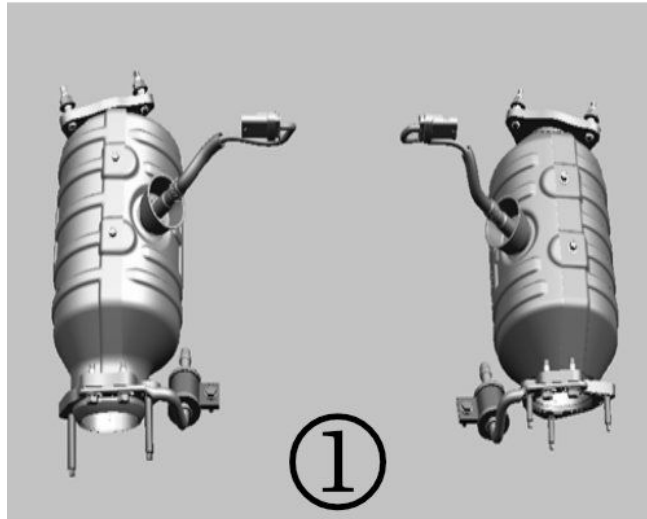
6825871

There are two different conditions in which the above codes may set. One is with the stock OE exhaust components (1) and the other is with an aftermarket non-OE exhaust components (2), as shown in the pictures above.

**Note:** The different position of the O2 sensors.

**Note:** If the catalytic converters **DO NOT** look like the ones shown above in the picture (1), the catalytic converter could be considered suspect. Also, please inspect for any aftermarket exhaust systems (2) as well.

DO NOT attempt to repair this concern if non-OE converters are found. Advise the customer that they need to return the vehicle to original OE equipped components. If the converters and/or exhaust system are OE and there are no other issues found, such as aftermarket calibrations per the latest version of Service Bulletin 09-06-04-026 etc., then proceed with applicable SI diagnostic procedures.
