## STAR ONLINE PUBLICATION

**Case Number:** S2208000154 Rev. A

**Symptom/Vehicle Issue:** Service Hybrid Electric Vehicle System Message Displayed In The IPC. Vehicle Shakes During A Cold Start And Noise Is Heard Near The P2 Motor. DTC's U0287-00 And B273C-00

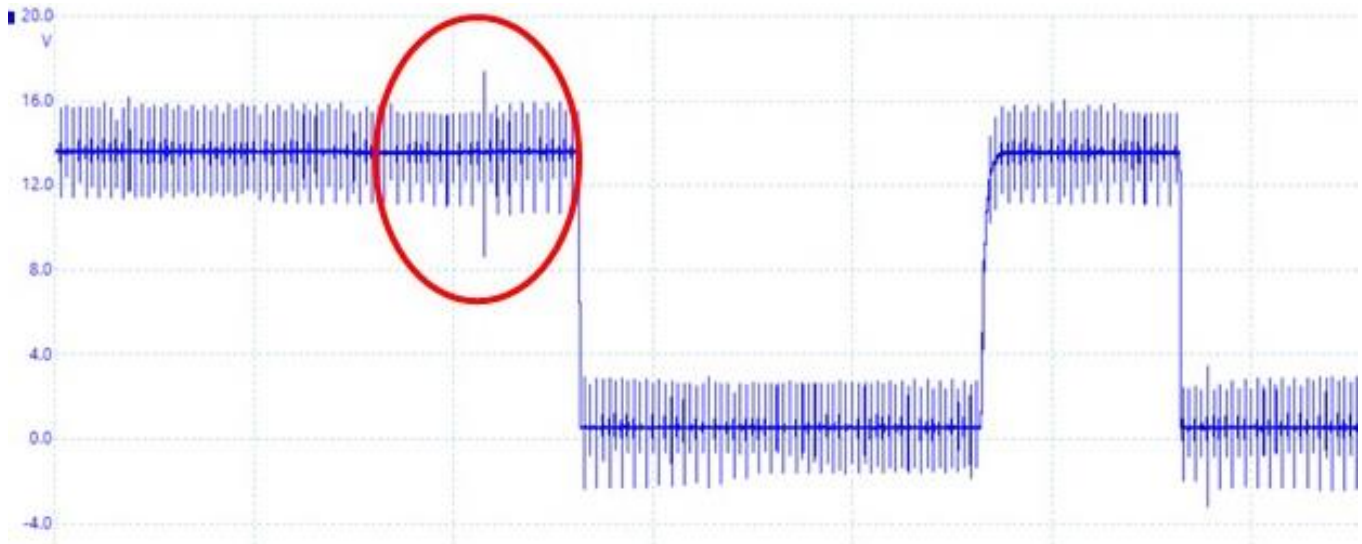
**Circuit R414. Electrical noise and voltage spikes caused by HV induction**

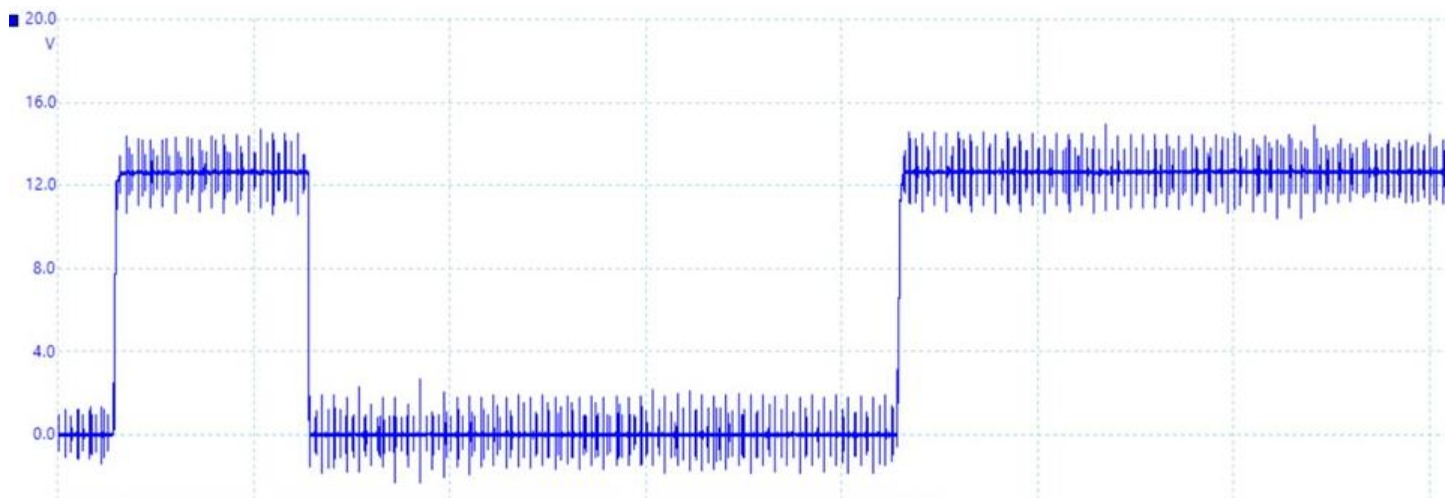
**Circuit R414. Known Good Vehicle. Normal scope pattern.**

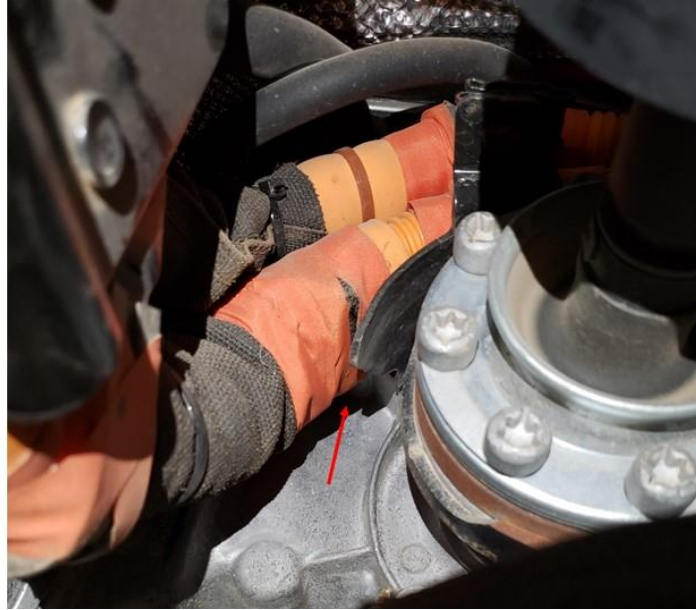
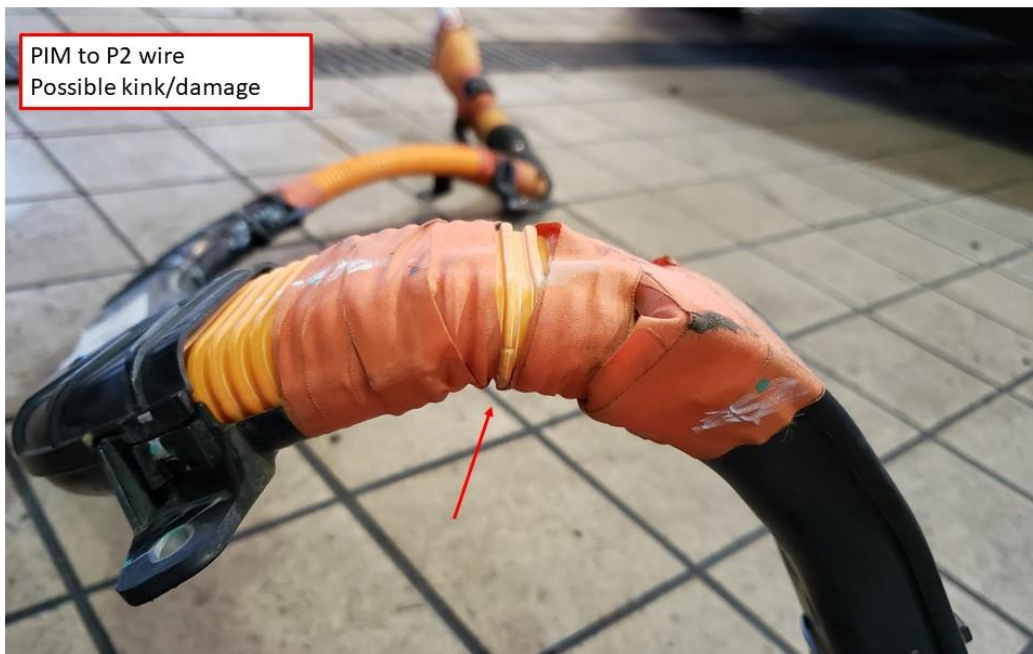
Inspect PIM to P2 wiring harness for rub through or damage near the transmission driveshaft CV joint shield.

PIM to P2 wire  
Possible kink/damage

**Repair Procedure:** If damage is found, replace the high voltage wiring harness. Follow all safety procedures for powering down and isolating the HV electrical system before removing any HV wiring.
