# Service Alert

| <b>Subject:</b><br><br>MAZDA CONNECT INTERMITTENT AUDIO NO SOUND AND/OR<br>STATIC NOISE FROM SPEAKERS | <b>Service Alert No.:</b> SA-008/25 |

2020-2024 CX-30  
2019-2024 Mazda3

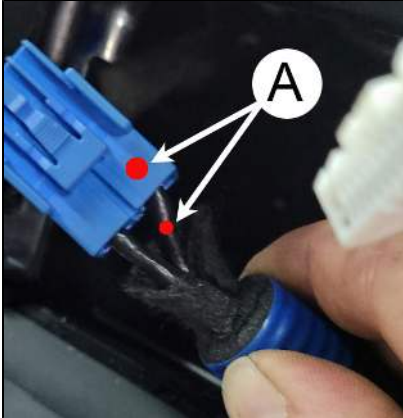
| PIN 6F is backed out | PIN 6F is untwisted and repaired |

5. Untwist pins 6F and 6H (straighten) and reinstall them into connector 0920-101F.

6. Pull on pins 6F and 6H to confirm they are locked and secured.

7. Confirm paint mark (A) alignment.
