**Flashing Function for Auxiliary Headlights Faulty / Fault Memory Entry "C11A401" in Control Unit for Headlight Bulb: Re-Code Control Unit for Headlight Bulb (231/24)**

Model Line: **Cayenne (9YA / 9YB)**

Model Year: **As of 2019 up to 2023**

Equipment: **Basic LED headlights (M-No. 8IT)**

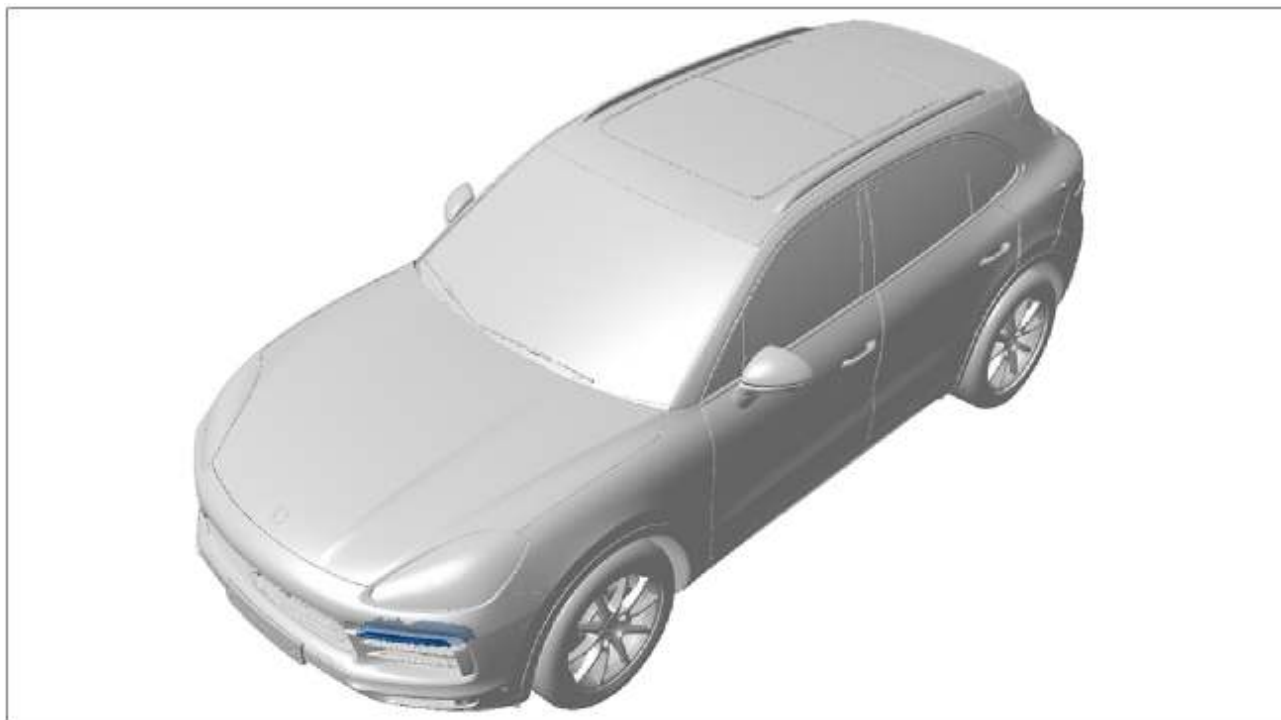
*Installation position of auxiliary headlight*
