| | Subsequent Repair Action | 2022-2024MY<br>EV6, EV6 GT (CV) |
| | SC302Y | June 2024 |
| SUBJECT: ICCU AND FUSE REPLACEMENT (SC302Y) | | |

This bulletin provides information related to the Technical Service Bulletin previously published under SC302, titled "ICCU and Fuse Inspection/Replacement and ICCU Software Upgrade." If DTC P1A9096 is present or stored after ICCU Software Upgrade has been performed per SC302, follow the instruction in this bulletin to replace the ICCU and ICCU fuse. Before conducting the procedure, verify that the vehicle is included in the list of affected VINs.

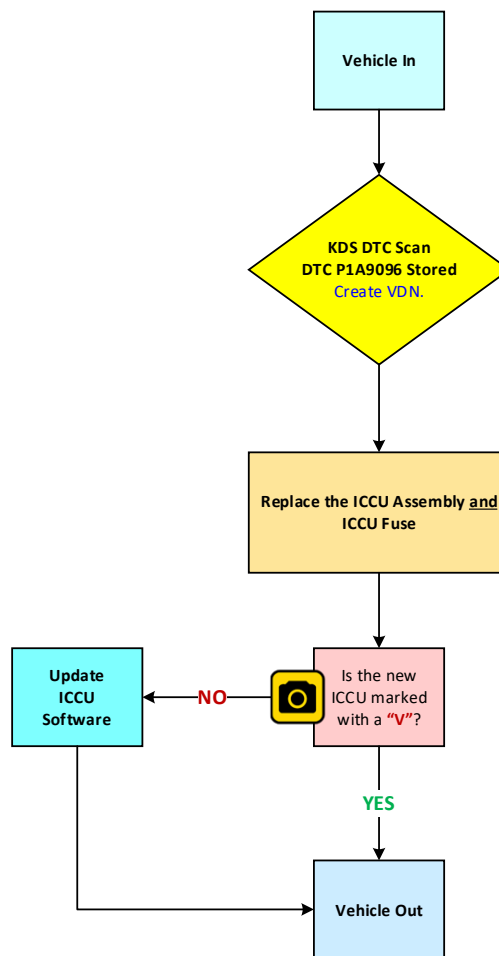
## Flowchart:

'Vehicle In' with DTC P1A9096 (after completing SC302 with the latest software)

DTC P1A9096 Stored + ICCU Assembly and ICCU Fuse Replacement

Is the 'new' ICCU Assembly marked with a letter "V"?

- If DTC is stored, replace the ICCU Assembly + ICCU Fuse (Page 5)

- No - Take a KVID photo of ICCU + Update the ICCU software (Pages 3-4)
- Yes - Vehicle OUT
