2022-2024MY  
EV6, EV6 GT (CV)

SC327Y

December 2024

## ICCU AND FUSE REPLACEMENT (SC327Y)

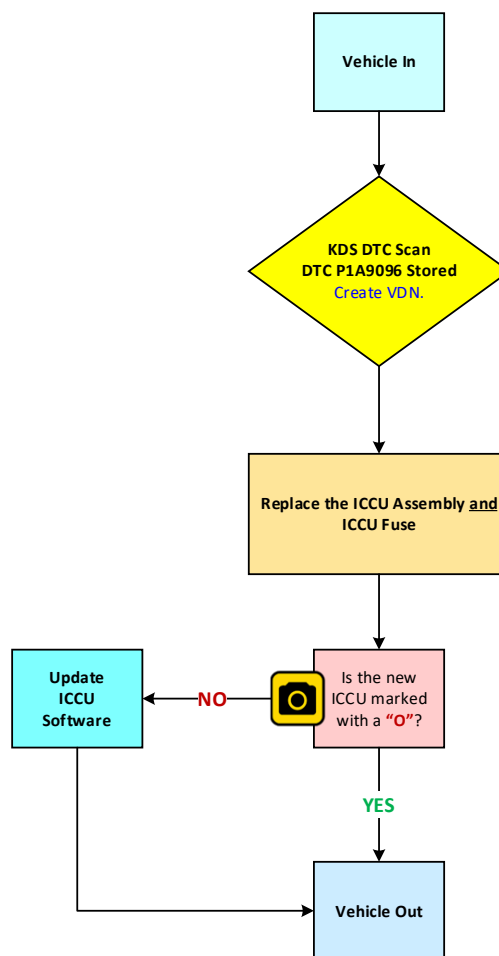
**'Vehicle In' with DTC P1A9096 (after completing SC327 with the latest software)**

**DTC P1A9096 Stored + ICCU Assembly and ICCU Fuse Replacement****Is the 'new' ICCU Assembly marked with a letter "O"?**

- If DTC is stored, replace the ICCU Assembly + ICCU Fuse (Page 5)

- No - Take a KDS Warranty Attachment photo of ICCU + Update the ICCU software (Pages 3-4)
- Yes - Vehicle OUT
