# Technical Service Bulletin

| Topic | New Continental GT and New Continental GTC - Window drop glass operation |
| Transaction No. | 2075821/1 |
| Release date | Feb 24, 2025 |

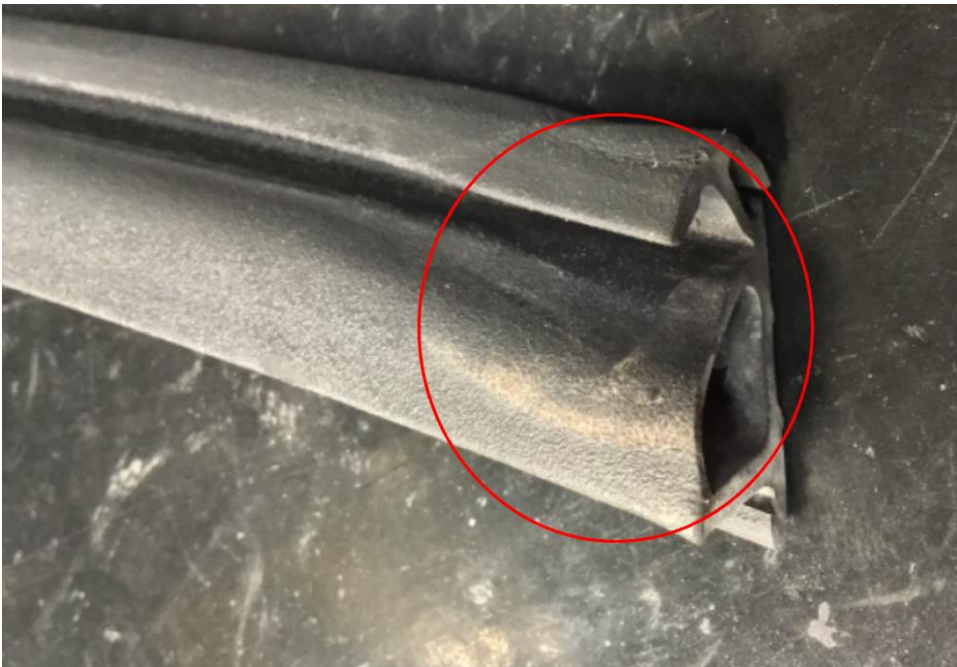
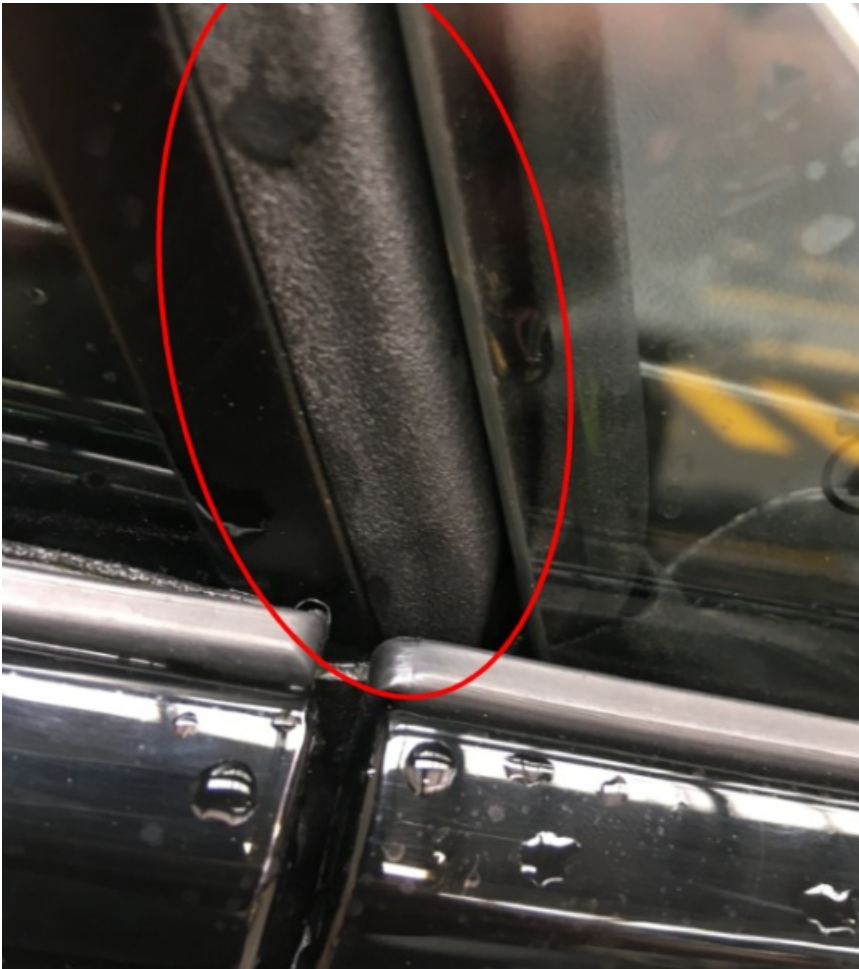
4) Conduct a thorough check of all Window / door seals for the following:

- Damage
- Splits
- Tears
- Misalignment
- Incorrectly fitted / located
- Drop glass seal deformation (see Figures 8 and 9 as examples)

**NOTE:** Any issues found with the window seals must be rectified before conducting the remaining steps
