# Technical Service Bulletin

| Topic | DTC P04F000 EVAP system high pressure purge line performance DTC logged |
| Brand | Bentley |
| Transaction No. | 2058573/5 |

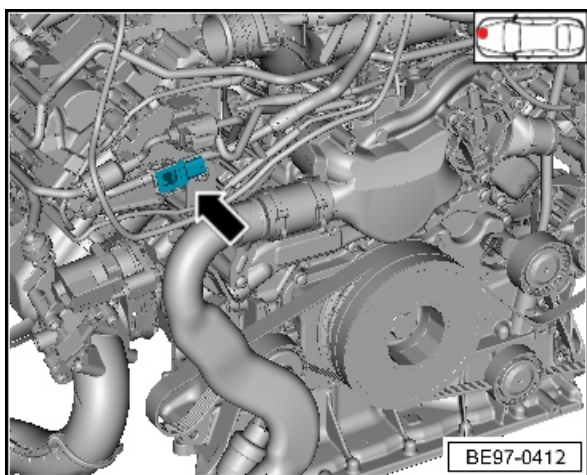
Figure 2

The DTC is related to mismatched terminal locations of the Pressure sensor for the activated charcoal filter system – G804 (Figure 2)

2) Should the terminal locations **NOT** be as shown in Figure 3, the terminals should be reallocated within plug as per the wiring diagram

- Refer to Repair manual Rep.Gr 20 - Tank ventilation pressure sensors - To remove and fit to gain access to the sensor connection
- Reallocate the sensor terminals as per Elsa pro wiring diagram instruction

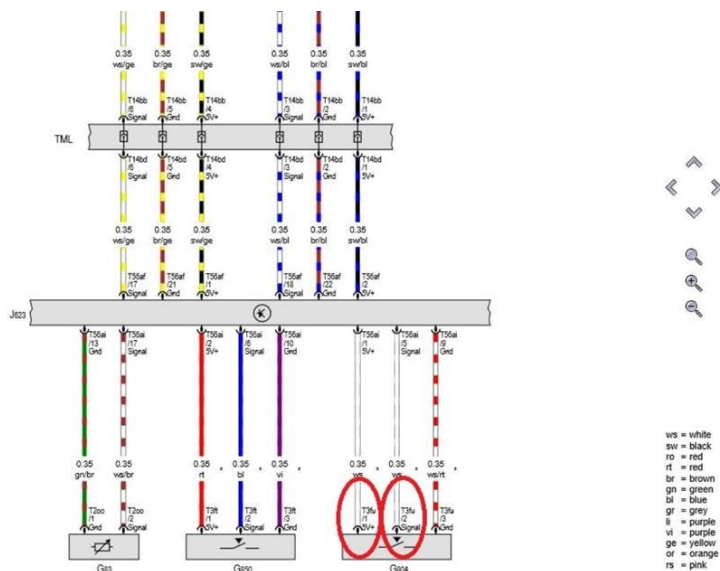
Figure 3

1) Refer to Wiring diagram 106/18 within Elsa pro (Figure 3)
