Technical Service Bulletin

| Topic | DTC B17B801 and/or B17B804 - evident within address 0019 and/or DTC U112300 evident in 00A5 |
| Brand | Bentley |
| Transaction No. | 2063855/11 |

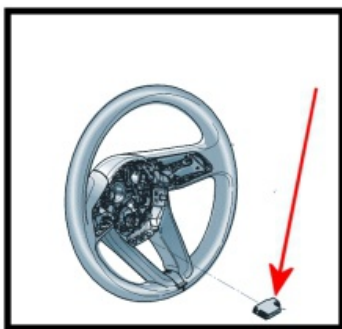
- Lane Assist and / or Traffic Assist are not functional
- DTC - B17B801 - Steering Wheel Touch Recognition Control Module evident within address 0019

- 1) Referring to Rep.Gr 69 - Remove the driver's air bag
- 2) Referring to Figure 1 - Replace the Steering Wheel Contact Detection control unit (J1158)

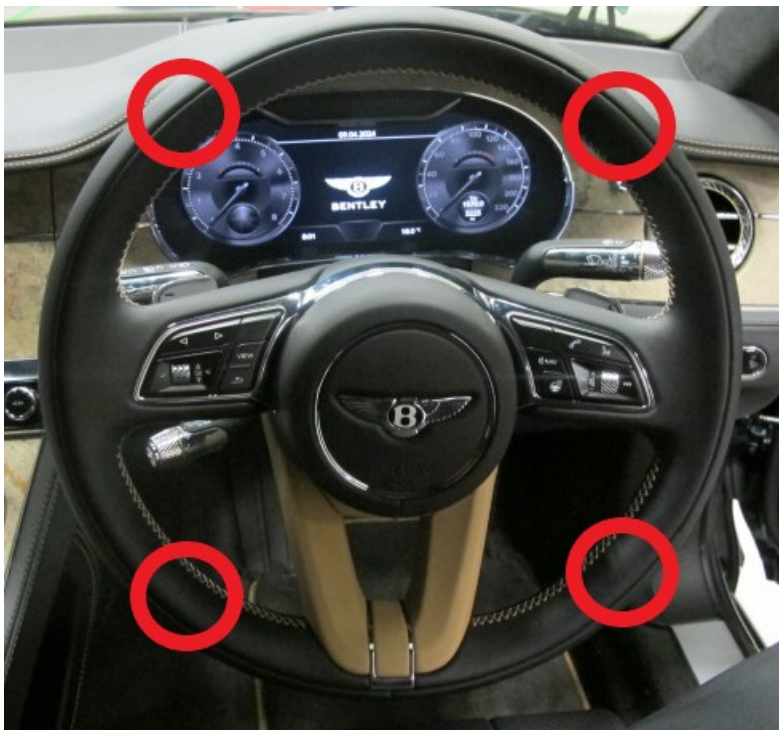
- Monitor the Sensor 2 and Sensor 3 values whilst holding the steering wheel at the points shown - **The expected values are between 40 and 60 and No malfunction Detected**

- Place hands (light grip) on the steering wheel at the various points as shown in Figure 3
