# Technical Service Bulletin

| Topic | V8 Kovomo - Engine MIL light on - DTC ' P04F000: EVAP system high pressure purge line performance' evident |
| Brand | Bentley |
| Transaction No. | 2065148/5 |

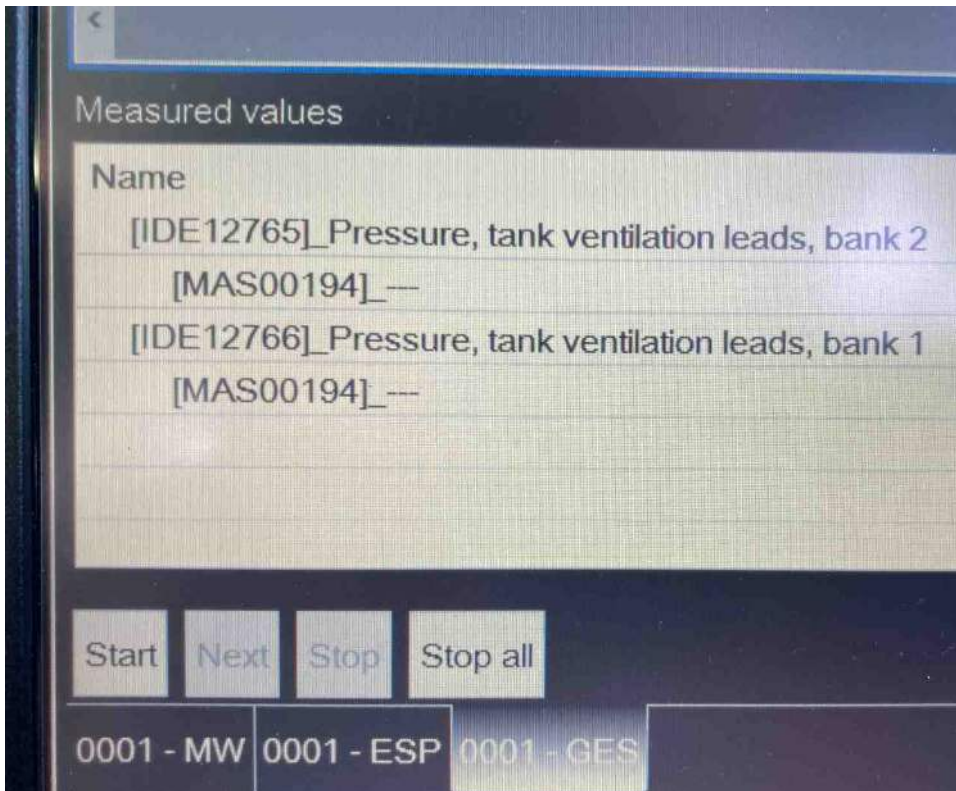
Figure 1

Referring to Figure 1:

IDE12765 (When monitored) fluctuates from the static value found (Ignition on/Engine Off)

With/without purge activation

IDE12766 (When monitored) DOES NOT fluctuate from the static value found (Ignition on/Engine Off)

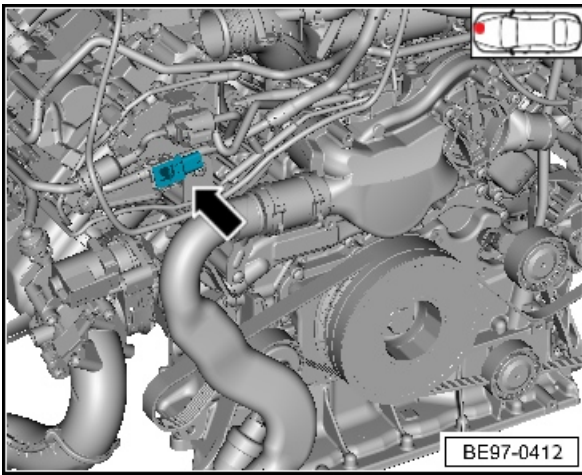
- Referring to Figure 2 - Locate the Pressure sensor connector (T3dd) for the activated charcoal filter system (G804)

- Disconnect T3dd
- Disconnect T56aj from the Engine control unit (J623)
- Referring to the applicable wiring diagram within in Elsa pro - Conduct a wiring integrity check

From T3dd (PIN's 1 and 2) - To Connector T56aj (PIN's 1 and 5)

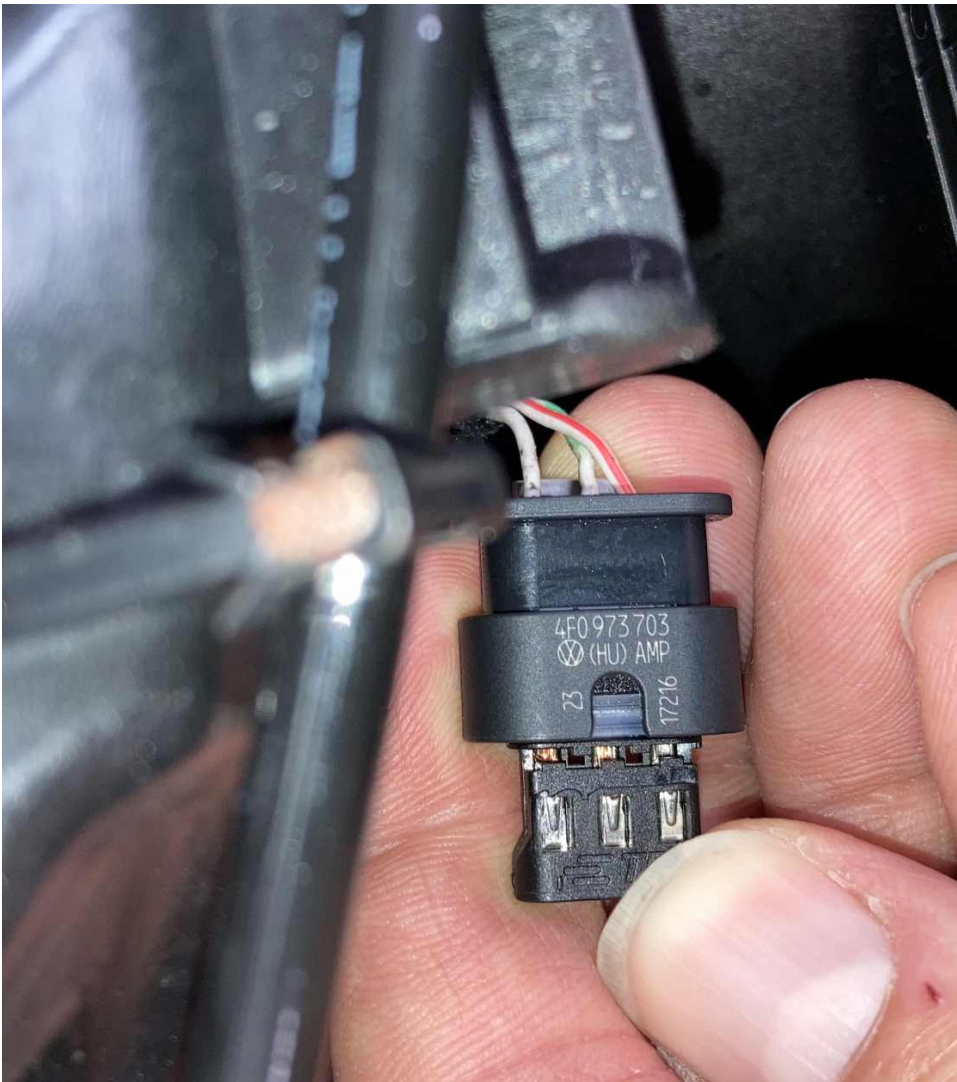
2) Referring to Figure 3 and the attached PDF instructions - De-pin/Remove PIN's 1 and 2 from connector T3dd

**TIP: As both wires are white, the green line which can be seen on the central white wire was applied to aid the operative when swapping the PIN's to the correct locations**

3) Install PIN 2 into PIN 1

4) Install PIN 1 into PIN 2

5) Conduct a wiring integrity check from T3dd (PIN's 1 and 2) - To Connector T56aj (PIN's 1 and 5)
