Technical Service Bulletin

| Topic | V8 Kovomo - DTC - P025C00: Fuel Pump Module Control Circuit Low logged in 0001 |
| Brand | Bentley |

New Continental GT/C-New Flying Spur-Bentayga-V8 Kovomo

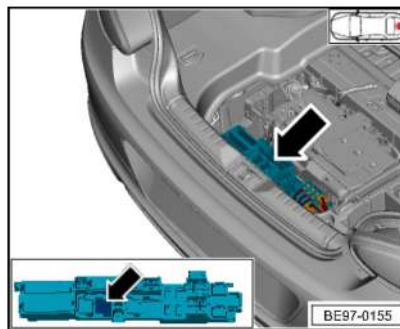
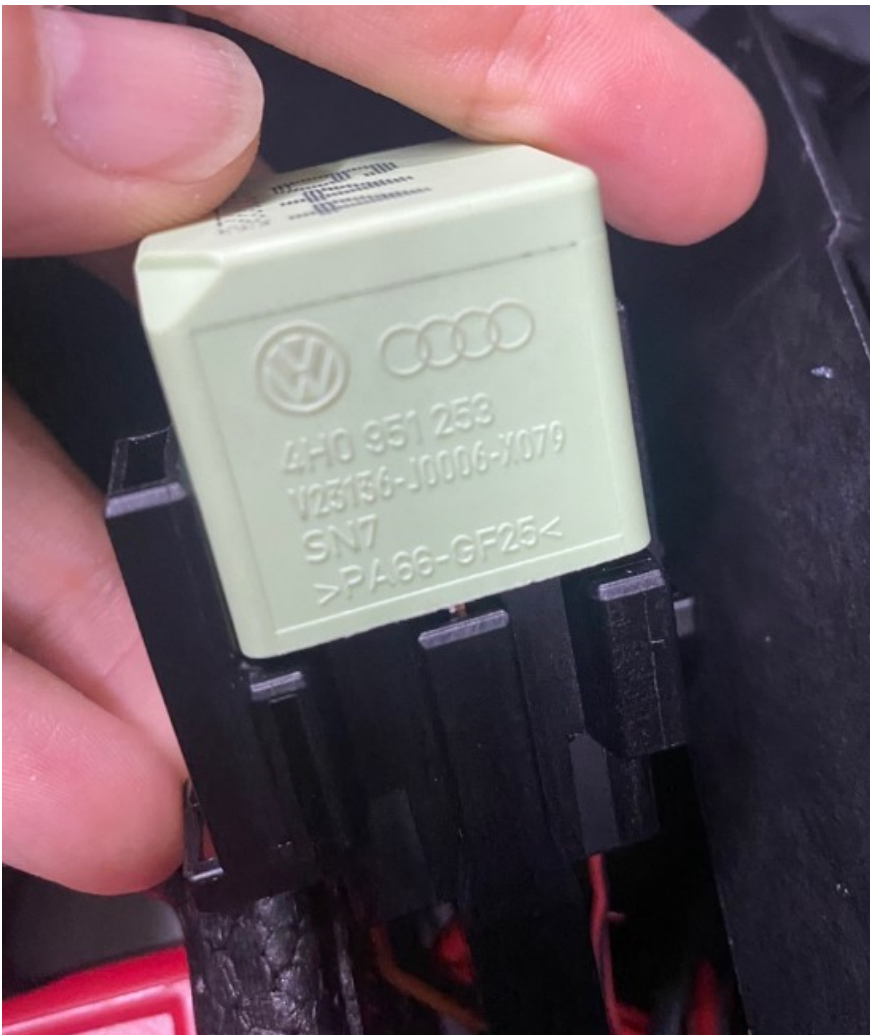
### Fuel pump relay -J17-

- Engine management light illuminated within the DIP
- DTC P025C00 Fuel Pump Module Control Circuit Low is evident within 0001 (Engine control unit)

1) Referring to Figures 1 and 2 - Locate (J17) fuel pump relay

- Remove (J17) from the carrier

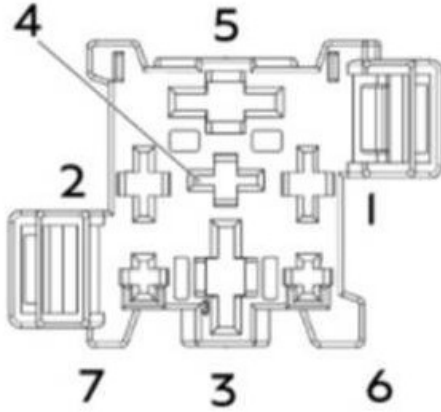
2) Referring to Figure 3 - Once removed conduct a visual check of all carrier terminals, check for the following:

- Loose terminals within the carrier
- Terminals which have spread (poor connection)
- Terminals which are damaged (poor connection)

4) Referring to Rep.Gr 97 - Wiring harness repairs - Renew the applicable terminals using the VAS 1978B wiring repair kit
