# Technical Service Bulletin

| Topic | DTC P096C00 and / or P096F00 evident within the Engine Control Module |
| Brand | Bentley |

## Bentayga Series - V8 Kovomo

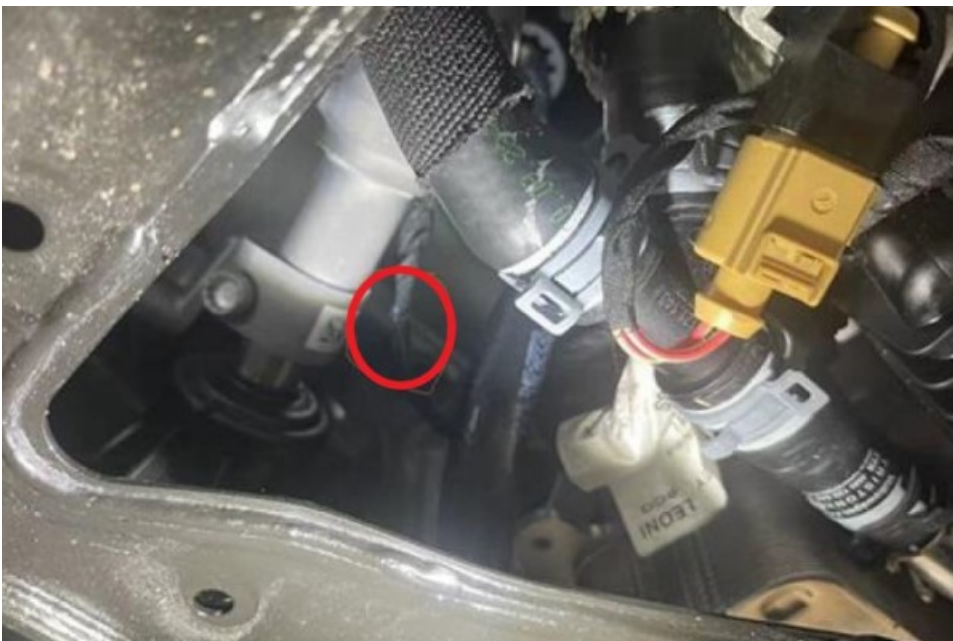
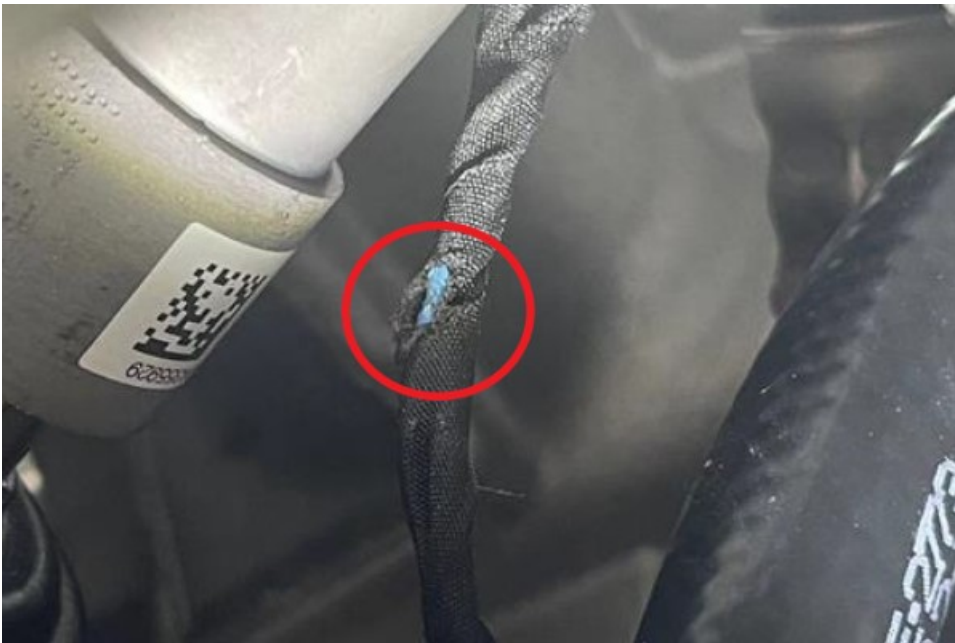
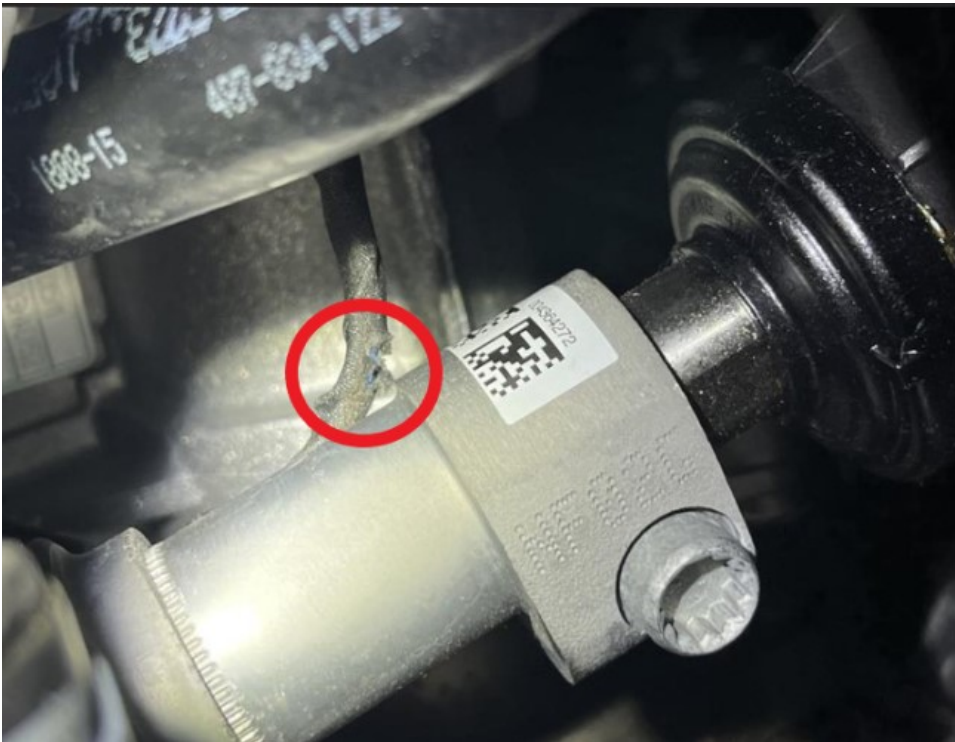
One or a combination of the following DTC's are evident within the Engine Control Module (ECM)

- P096C00 Transmission coolant valve electrical malfunction

- P096F00 Transmission coolant valve short circuit to ground

- 1) Referring to the applicable wiring diagram - Conduct an electrical integrity check of the N509 gearbox cooling valve circuit
- 2) Referring to Figures 1, 2 and 3 - Conduct a visual inspection to confirm if the harness shown (CIRCLE) has any damage relating to contact with the steering shaft .

In the event the issue is as described the operative must conduct the remaining instructions (step 3 and 4) to completion and repair the damaged cable(s)

3) Referring to Rep.Gr 97 - Wiring harness repairs - Repair the damaged wiring using the VAS 1978B wiring repair kit
