# Technical Service Bulletin

| Topic | Warnings within the DIP for the rear steering system - DTC B200096 and/or P060700 evident within diagnostic address 00CB |
| Brand | Bentley |
| Transaction No. | 2069252/3 |

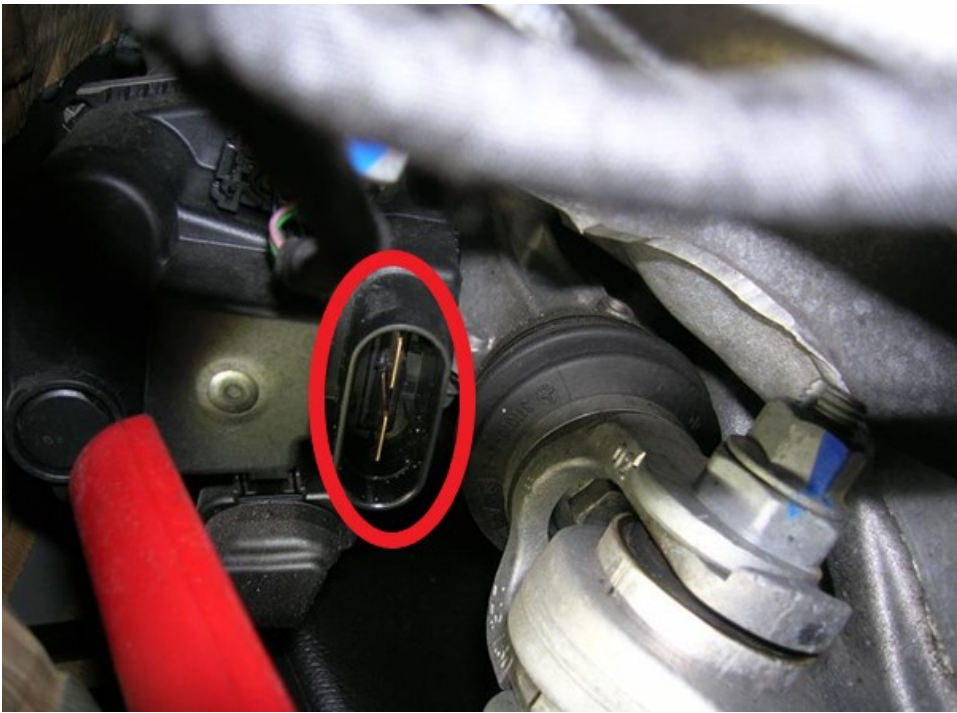
Figure 1

2) Referring to the applicable wiring diagram, conduct an electrical integrity check for the rear wheel steering control unit /J1019 (rear steering rack) in particular the 2-way 12V plug and connector (see the example shown in Figure 1) for any signs of corrosion or water damage

- Refer to the applicable wiring diagram - Check all applicable earth points of J1019 for Cleanliness, security and integrity - Rectify as applicable and retest to confirm if the DTC's are still evident
- If no faults were identified after conducting the wiring integrity checks the operative should confirm no faults were found and attach a current ODIS log to a new or existing DISS query
- The operative must await feedback from the new or existing DISS query before conducting any further work
