## Technical Service Bulletin

| <b>Topic</b> | 24 Intake Manifold Sensor, MIL on, DTCs U060A00, U060900 |
| <b>Transaction No.</b> | 2076749/1 |

### RS 6 and RS 7 with EA825 V8 TFSI

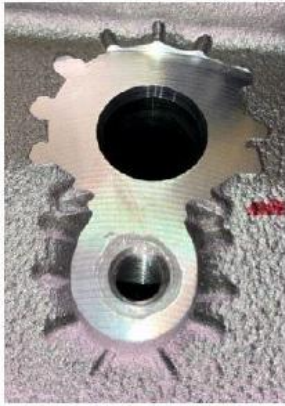
**Figure 1.** *Contact surface on the intake manifold side.*

Before fitting the new sensor, please take a photo which clearly shows the contact surface on the intake manifold side and upload it to DOC-IT.

Refer to the Figure 1 of the contact surface on the intake manifold side for an example.

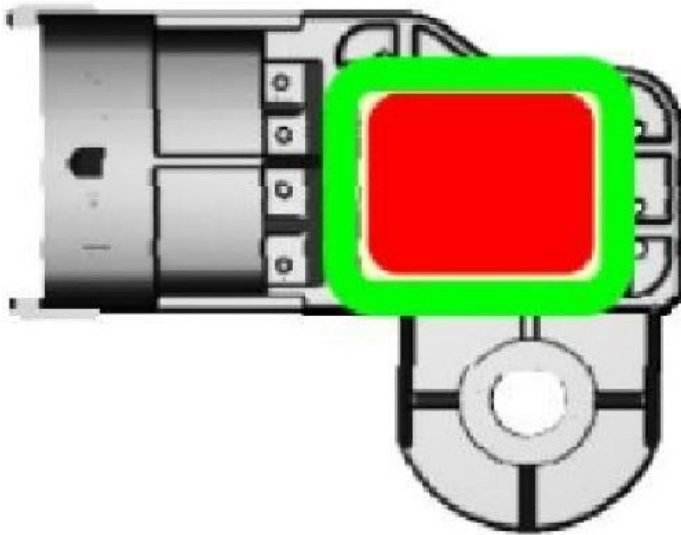
**Figure 2.** *Ensure no force is applied to the red area in the above diagram.*

When installing the new intake manifold pressure, please ensure that the sender cover is not stressed/ no application of forces (see red surface in Figure 2). Please therefore do not press on the surface during installation as this could damage the sender.
