## Technical Service Bulletin

| <b>Topic</b> | 93 e-tron GE various warning messages in the cluster, electric motor leaking P0AA600 |
| <b>Brand</b> | Audi |
| <b>Transaction No.</b> | 2073858/7 |

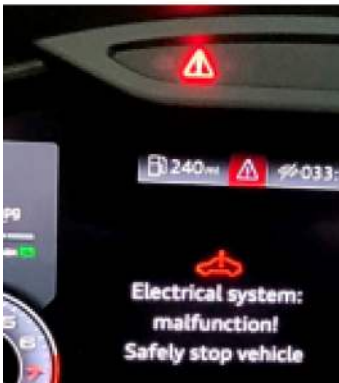
- A Drive System/Electrical System Malfunction message (Figure 1) appears in the in the instrument cluster; the warning may not be present at the time of inspection.

**Figure 1.** Warning lamp associated with message.
