## Technical Service Bulletin (TSB)

### Flash: Electronic Vehicle Control Unit (EVCU) Updates

| REFERENCE: | TSB: 08-073-25<br>GROUP: 08 - Electrical | Date: | March 20, 2025 | REVISION: | — |
| VEHICLES AFFECTED: | 2025 (LB) Dodge Charger<br>This bulletin applies to vehicles built on or before January 15, 2025 (MDH 0115XX) equipped with 400V G2500 FR/RR Elec Drive Motors (Sales Code ELD). | | | MARKET APPLICABILITY:<br><input type="checkbox"/> NA<br><input type="checkbox"/> SA<br><input type="checkbox"/> EE<br><input type="checkbox"/> MEA<br><input type="checkbox"/> IAP<br><input type="checkbox"/> CH | |

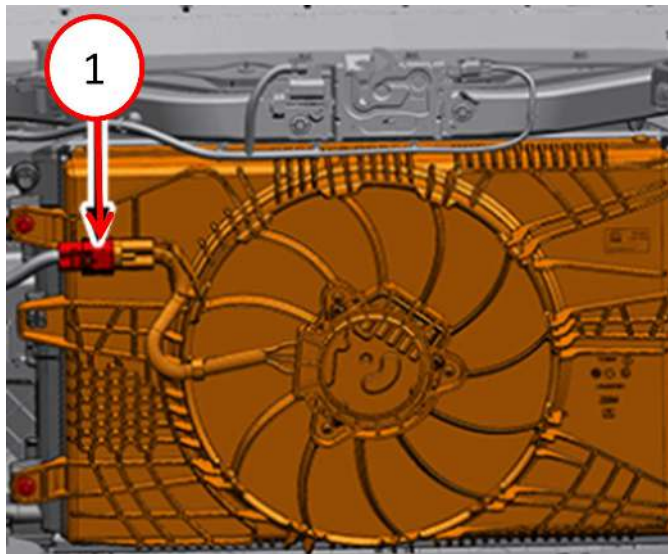
**Fig. 1**  
Cooling Fan Assembly

1 - Wire Harness To Disconnect/Connect

4. Disconnect the cooling fan wire harness connector [Fig. 1](#).

21. Connect the cooling fan wire harness connector [Fig. 1](#).
