## Technical Service Bulletin (TSB)

### High Voltage Wiring Repair

| REFERENCE: | TSB: 08-082-25<br>GROUP: 08 - Electrical | Date: | March 21, 2025 | REVISION: | — |
| VEHICLES AFFECTED: | 2021 - 2024 (JL) Jeep Wrangler<br>This bulletin applies to vehicles equipped with the 2.0L I4 DOHC DI Turbo PHEV Engine (Sales Code ECX). | | | MARKET APPLICABILITY:<br><div><input type="checkbox"/> NA<input type="checkbox"/> MEA</div> <div><input type="checkbox"/> SA<input type="checkbox"/> IAP</div> <div><input type="checkbox"/> EE<input checked="" type="checkbox"/> CH</div> | |

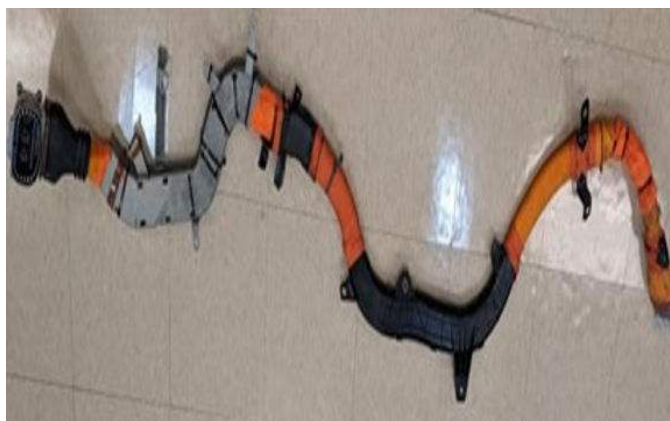
**Fig. 1**  
HV Cable Harness

2. Inspect the PIM to P2 HV cable harness for rub through or damage near the transmission driveshaft CV joint shield.

1. Remove the PIM to Transmission HV cable harness [Fig. 1](#). Refer to the detailed service procedures available in DealerCONNECT/Service Library under: Service Info> 12 - Electrified Powertrain System / High Voltage Battery / Cables / Removal and Installation.

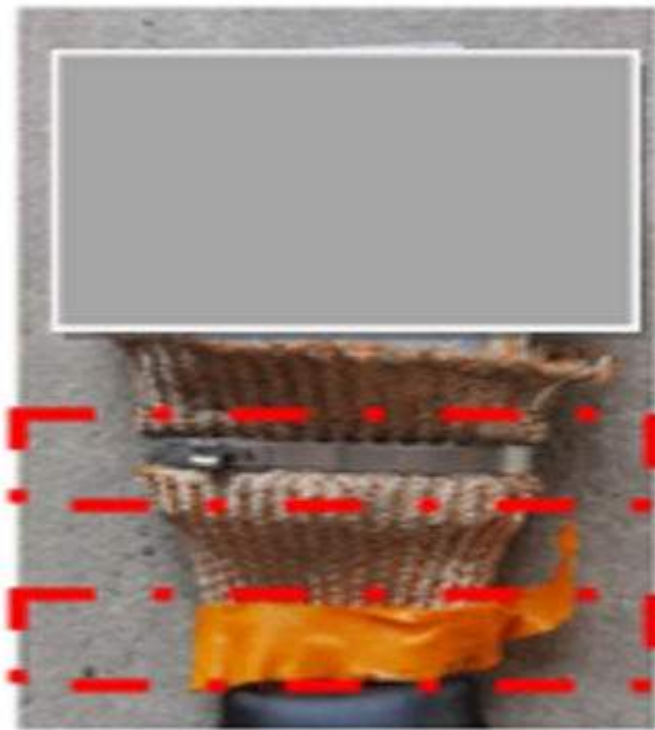
**Fig. 5**

Proper HV Cable Harness Connector Mesh And Clamp Positioning

- If the oxidization is too severe and cannot be cleaned, sand polish the groove, (**DO NOT over polish**).
  - Use the air compressor gun to blow away the dust and make the area clean.
12. Put back the metal mesh shielding layer around the HV cable harness connector and use the original metal clamp to secure the connector and shielding layer. Wrap with electrical tape [Fig. 5](#).

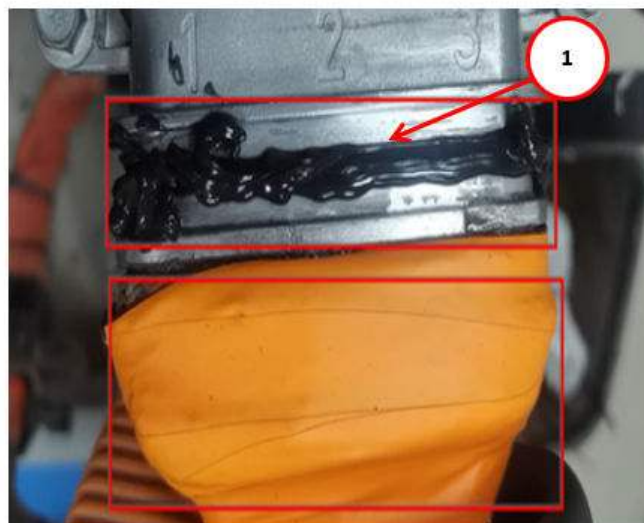
**Fig. 6**

HV Cable Harness Connector Sealed Using Darbond 2598

1 - Sealed HV Cable Harness Connector

13. Apply Darbond 2598 sealing compound evenly around the tightening area between the HV cable harness connector and the rubber sleeve in Zone A [Fig. 4](#) and [Fig. 6](#).
