**Technical Service Bulletin (TSB)**  
**Powertrain Control Module (PCM)**  
**Wiring Harness Contacting PCM Bracket**

| REFERENCE: | TSB: 08-086-25<br>GROUP: 08 - Electrical | Date: | March 22, 2025 | REVISION: | — |

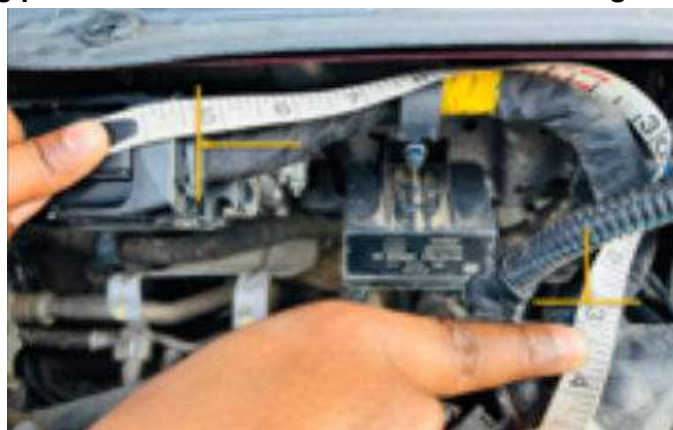
**Fig. 1**  
**PCM Harness Measurement**

**NOTE:** Measuring point: From PCM Connector to channel edge [Fig. 1](#), [Fig. 2](#).

1. Measure the PCM harness wiring harness length.

2. Is the wiring harness damaged and/or is the harness length longer than 250 mm (9.8 in.)?
  - YES>>> Proceed to [Step 3](#).
  - NO>>>The harness is ok. Perform further diagnostics.
3. Is the wiring harness damaged?
  - YES>>> Proceed to [Step 4](#).
  - NO>>> Proceed to [Step 5](#).
4. Replace the PCM wire harness.
5. Tape up the harness [Fig. 3](#).
