# Technical Service Bulletin

| Topic | Bentayga and New Flying Spur Hybrid - DTC P103A00 evident - Engine Oil Fuel Portion Too High |

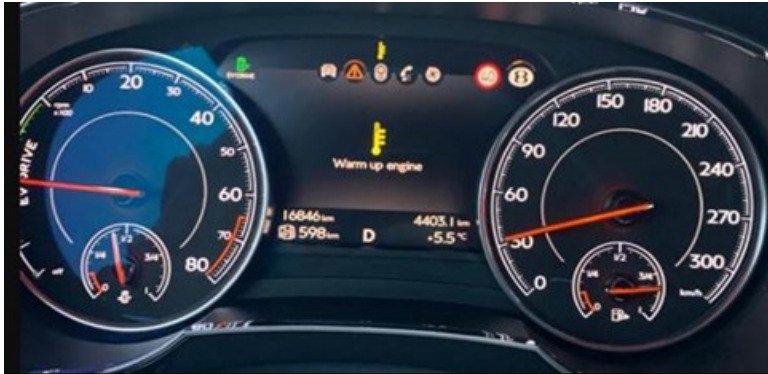
Figure 1

- Warning message within the DIP
- The message asks the customer to 'warm up engine' accompanied by a yellow warning (Figure 1) No other symptoms are experienced.

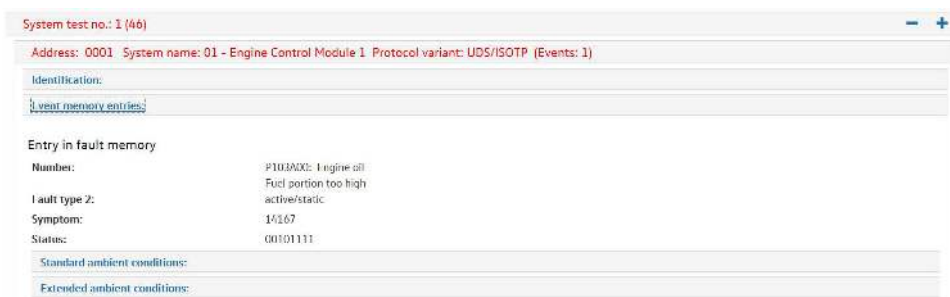
Figure 2

- DTC P103A00 evident - Engine Oil Fuel Portion Too High (Figure 2)

The warning is caused by the level of unburnt fuel in the engine oil. This value is calculated by the Engine Control Module (ECM) and is based on the driver usage pattern

The more cold starts the Internal Combustion Engine (ICE) is exposed to the higher the chance of fuel making its way into the engine oil via the cylinders

When the fuel calculation reaches the pre-programmed amount this then causes the DTC to be triggered

2) Referring to the Rep.Gr 17- Check the engine oil level *NOTE: Ensure the method within Rep.Gr 17 is followed*

- **IMPORTANT:** In the event the engine oil level is deemed as excessively high, the oil level should be reduced/corrected - Refer to Rep.Gr 17 - Drain the required amount of engine oil to adjust the oil level to specification

3) Drive the vehicle in SPORT mode for 30 KM (***Observing all local speed limits***) with enthusiastic driving to reduce the fuel MWB value (IDE09531) to less than 50 grams

- In the event the MWB value (IDE09531) has been successfully reduced (Lower than 50 grams) Erase the applicable DTC's
