# Technical Service Bulletin

| Topic | Bentayga V8 Kovomo - DTC P310B00 with Symptom Code 2638 - Check Engine Lamp - Fuel Pressure Regulation |
| Transaction No. | 2058484/13 |
| Release date | Mar 3, 2025 |

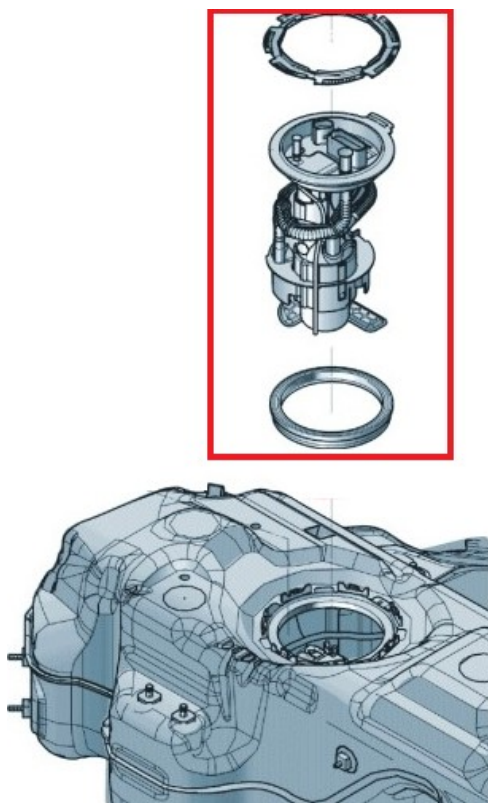
1) Referring to the example shown in Figure 1 - Check the actual pressure value

- In the event the fuel pressure actual value is above 450kPa the Fuel Delivery Module within the fuel tank (Figure 2) should be replaced

- In the event the fuel pressure actual value is above 475kPa (2023MY) the Fuel Delivery Module within the fuel tank (Figure 2) should be replaced

| Low fuel pressure, specified value | 450.0 | kPa |
| Fuel low pressure, actual value | 501.3 | kPa |

### The fuel tank flange seal and securing ring should also be replaced

- Refer to Repair Group 20 Fuel supply, gas operation / 4.0L V8 TSI / Fuel pump, fuel level sensors, and jet pump (RH) - To remove and fit
