Technical Service Bulletin

| Topic | Bentayga V8 Kovomo - DTC P304300 with symptom code (10061) - Fuel Pump Mechanical Malfunction - MIL lamp |

Bentayga Series - V8 Kovomo

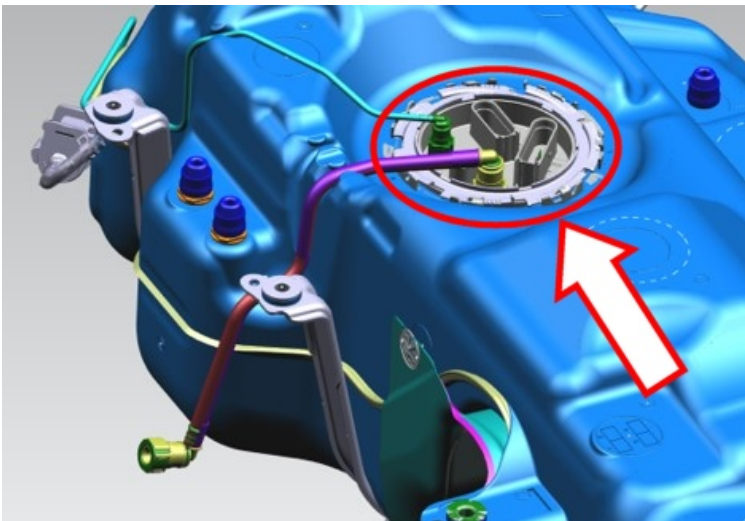
Figure 1

4) Conduct a visual inspection of the fuel pump delivery module (Top) for any obvious signs of damage (Figure 1)

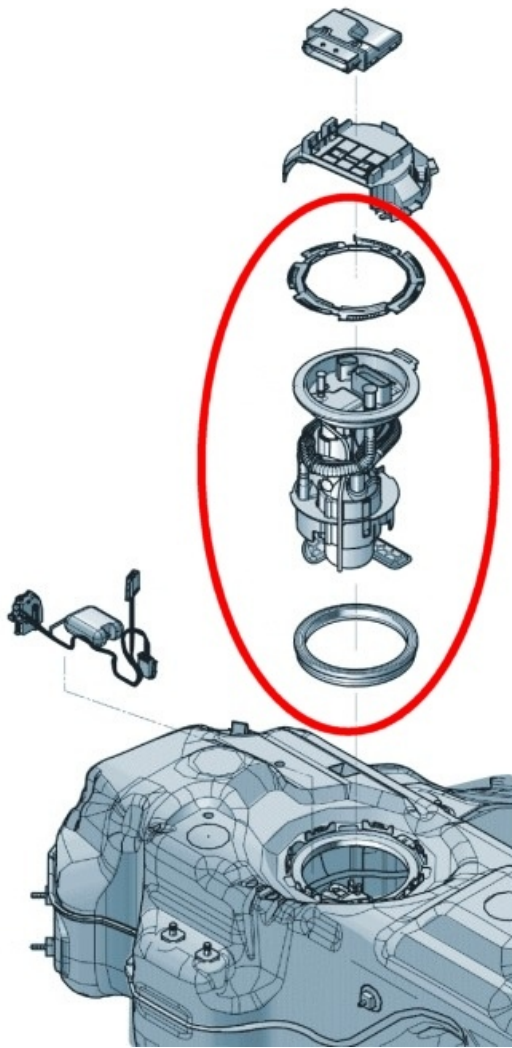
Figure 2

DTC P304300 – with symptom code (10061) - Fuel Pump Mechanical Malfunction evident

5) Should all the advised checks detailed in steps 1 to 4 be to specification – Replace the Fuel Delivery Module within the fuel tank (Figure 2) - Refer to Repair Group 20 Fuel supply, gas operation / 4.0L V8 TSI / Fuel pump, fuel level sensors, and jet pump (RH) – To remove and fit
