# Technical Service Bulletin

| Topic | Bentayga V8 Kovomo - Engine MIL light on - DTC "O2 Sensor Signals Swapped Bank 1 Sensor 2/ Bank 2 Sensor 2 |

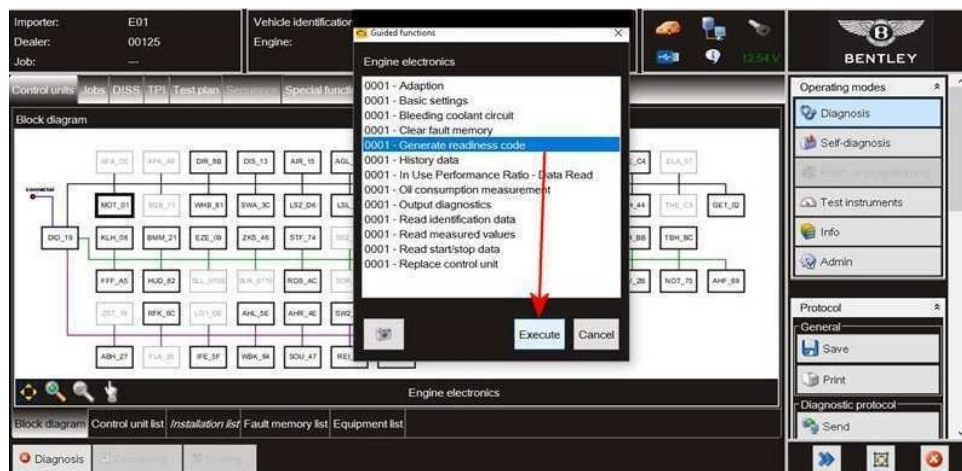
DTC P004100: "O2 Sensor Signals Swapped Bank 1 Sensor 2/ Bank 2 Sensor 2 is evident within address 0001 (Engine control unit) and MIL light active after attempting to conduct a readiness test

- Referring to Figure 1 - Select Guided functions from 01 - Engine Control Module 1
- Select Generate readiness code
- Select Execute and follow the readiness code procedure to completion as per all on screen prompts
