# Technical Service Bulletin

| Topic | DTC P14AB00 and/or other related exhaust flap DTC's - Warning lamp evident within the DIP |
| Brand | Bentley |
| Transaction No. | 2055664/2 |

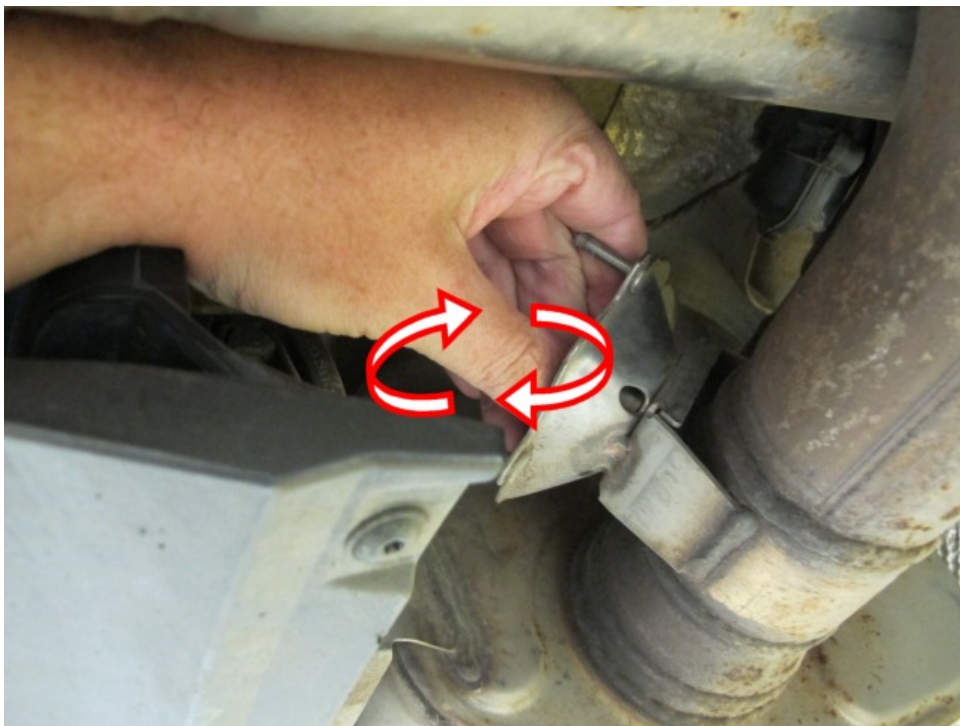
Figure 1

- Check and confirm the exhaust flap can be rotated by hand (clockwise and anti-clockwise) without the control unit fitted (Figure 1)

- Should no issue be evident with the exhaust flap and it can be freely rotated by hand - Replace the defective exhaust flap control unit Refer to Rep.Gr 26
