## "Coolant level too low" warning message shown in instrument cluster

| Topic number | LI20.30-P-078333 |
| Validity | Model 243 |
| Reason for change | New expansion reservoir |

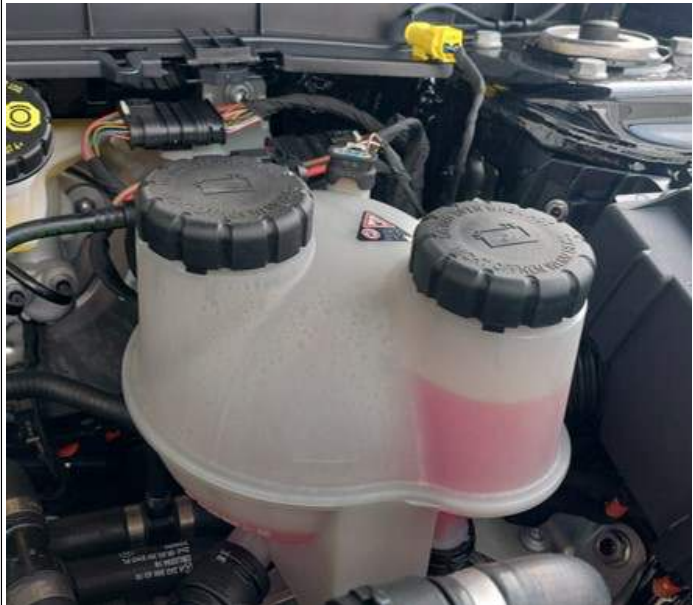
| Attachments | |
|---|---|
| Beanstandung Kühlmittelstand zu gering.jpg | Coolant level after a journey and before opening a closing cap (pressure on system, coolant level in chamber of level sensor pushed below the warning threshold)) |

The vehicle's electric drive motor transports air into the cooling system.  
The air transported into the cooling system leads to the formation of an air cushion in the expansion reservoir, which in turn causes the coolant level to drop below the warning threshold of the coolant's fill level sensor when driving.  
After opening the closing cap, the coolant level is OK again.

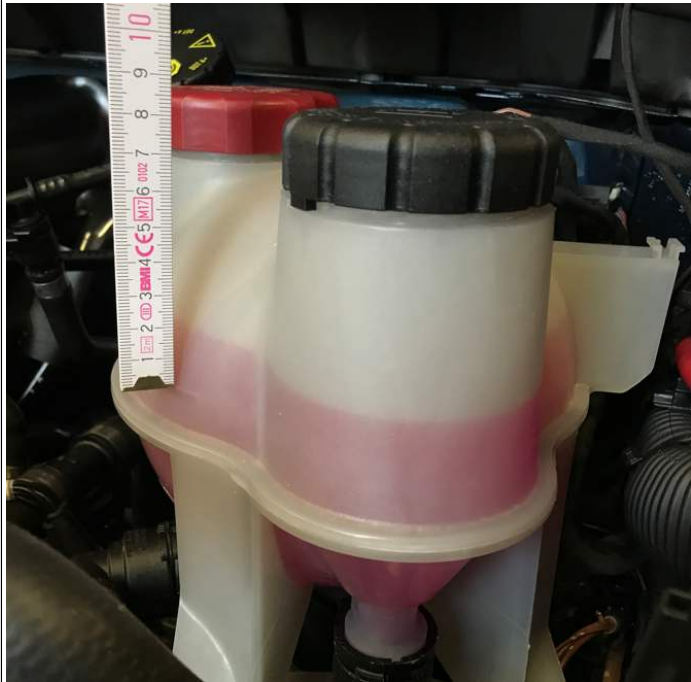
| Attachments | |
|---|---|
| <a href="#">Ausgleichsbehälter BR243 Kühlmittel 20mm über Max.PNG</a> | Original expansion reservoir A243 500 41 00 with red closing cap on large chamber, fluid level raised by roughly 20 mm above MAX. |

Replace the black cap A210 501 06 15 of the large working chamber of the expansion reservoir with a red cap A297 500 51 00

and the coolant level rises by roughly 20 mm above the MAX. marking.

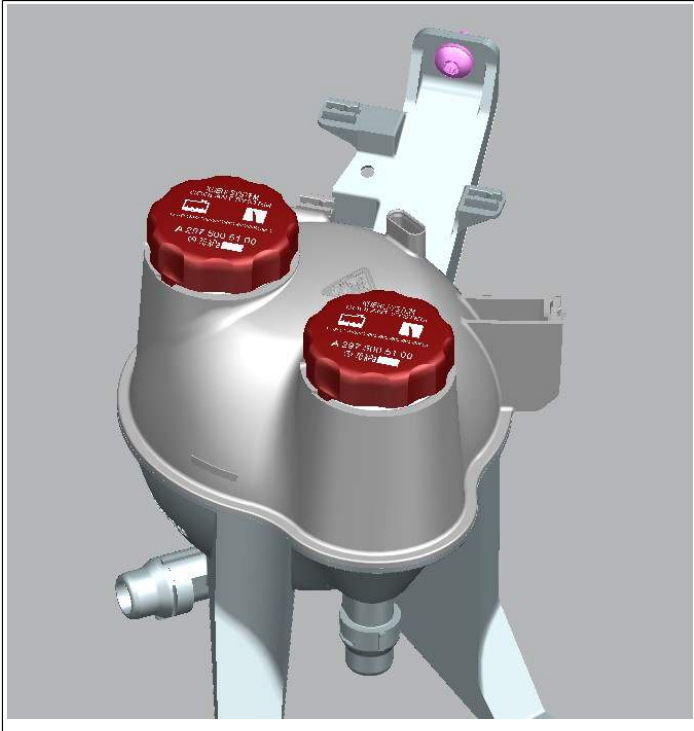
| Attachments | |
|---|---|
| <a href="#">neuer Behälter mit zwei roten Verschlussdeckeln.jpg</a> | Current expansion reservoir A243 500 60 00 with internal connection for both chambers and with two red closing caps A 297 500 51 00 |

On vehicles in which the problem cannot be rectified by this procedure, the expansion reservoir A 243 500 41 00 is replaced by the modified container A243 500 60 00.

The new expansion reservoir is to have two red closing caps A 297 500 51 00 fitted to it, and the coolant level is to be set to the MAX. marking.
