# Service Bulletin

Bulletin No.: 25-NA-050

**Subject: DTC U0265 and Other Front Camera Module Software Concerns**

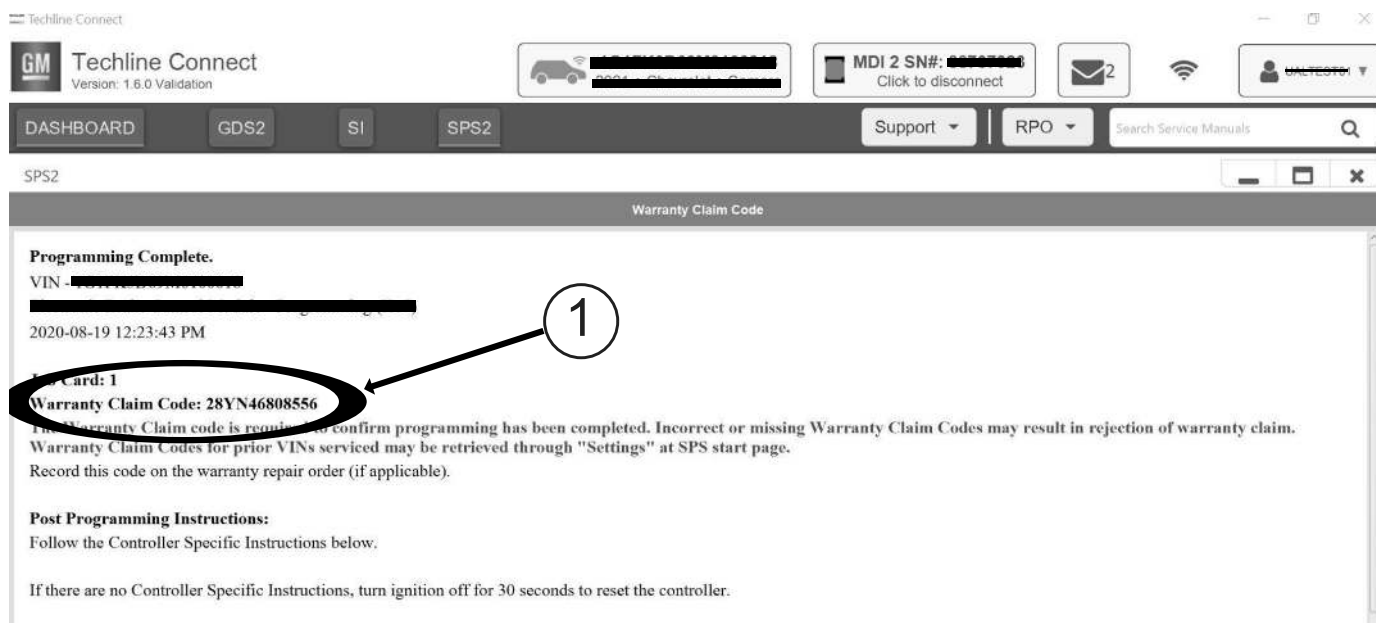
5644478

**Note:** The screenshot above is an example of module programming and may not be indicative of the specific module that is being programmed. Module selection and VIN information have been blacked out.

**Important:** To avoid warranty transaction rejections, you **MUST** record the warranty claim code provided on the Warranty Claim Code (WCC) screen shown above on the job card. Refer to callout 1 above for the location of the WCC on the screen.
