| <b>Subject:</b><br><br><b>ENGINE NO START / NO CRANK WITH DTC P0615:12 AND/OR B112A:12 STORED</b> | <b>Service Alert No.: SA-014/25</b> |
| | <b>Last Issued : 03/06/2025</b> |

2017-**2025** CX-5

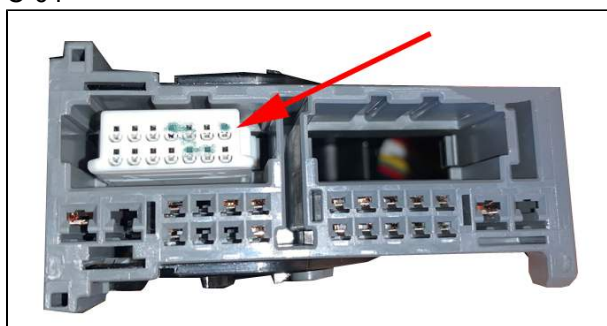
This may be caused by water contamination/corrosion at electrical connector C-04 due to:

- Windshield tint installation:
  - Windshield tint installed to block UV light. The water used during the installation of the tint may run down behind the dashboard. Carefully inspect the windshield to see if window tint has been installed or not. Some window tint film appears clear and is for UV light only.
- Windshield repair/replacement:
  - Poor windshield sealing during installation can cause an internal water leak. Water may run down behind the dashboard.

1. Verify customer concern.
2. Inspect electrical connector C-04 for water contamination/corrosion. Is water corrosion present?
  - Yes - Repair or replace connector C-04.
  - No - This service information does not apply. Go to MGSS:
    - [DTC P0615:12 \[START STOP UNIT\]](#)
    - [DTC B112A:12 \[START STOP UNIT\]](#)
3. Verify repair.
