### Check engine light or Adblue warning with fault codes P206B31, P203B31, or P300494 when outside temperatures are below 32 degrees Fahrenheit. SCR Gen4 (KP7)

| Topic number | LI49.20-N-078838 |
| Validity | Model 907 with SCR Gen4 (KP7) |

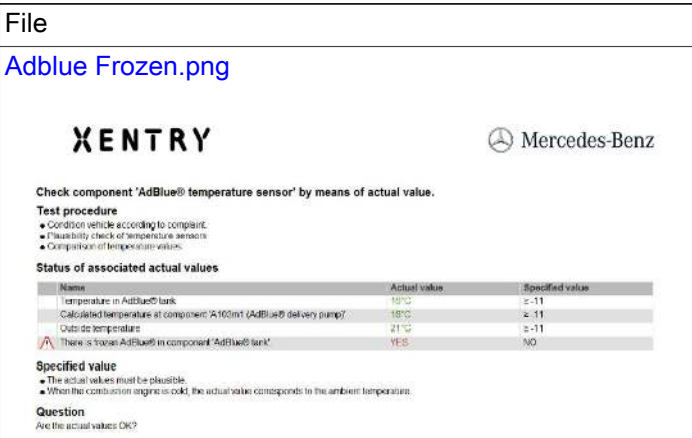
| Attachments | |
|---|---|
| <a href="#">Adblue Frozen.png</a> | Adblue Frozen |

5. Reset the Adblue Tank fill level via XENTRY. Please print the XENTRY pages that indicate the AdBlue tank fill-up was completed successfully.
- NOTE-- If the XENTRY still shows that there is frozen Adblue or the concentration is still inaccurate after draining and filling, please refer to the attachments 'Adblue Frozen' and 'Adblue Concentration' and proceed to step D.

## D. Damaged Adblue Level Sensor/Concentration Sensor

1. Replace the Adblue Tank
2. With the vehicle running and XENTRY hooked up displaying Adblue level values
3. Fill the Adblue Tank SLOWLY and do not overfill, verify fill level reflects the change in the Adblue level
3. Reset the Adblue Tank fill level via XENTRY
4. Complete LI49.20-N-075995 for Adblue warning reset.
