## Technical Service Bulletin

| <b>Topic</b> | 91 Emergency call function (SOS) fault, function partially available. Please contact workshop, DTC B105313 |
| <b>Brand</b> | Audi |
| <b>Transaction No.</b> | 2048360/6 |

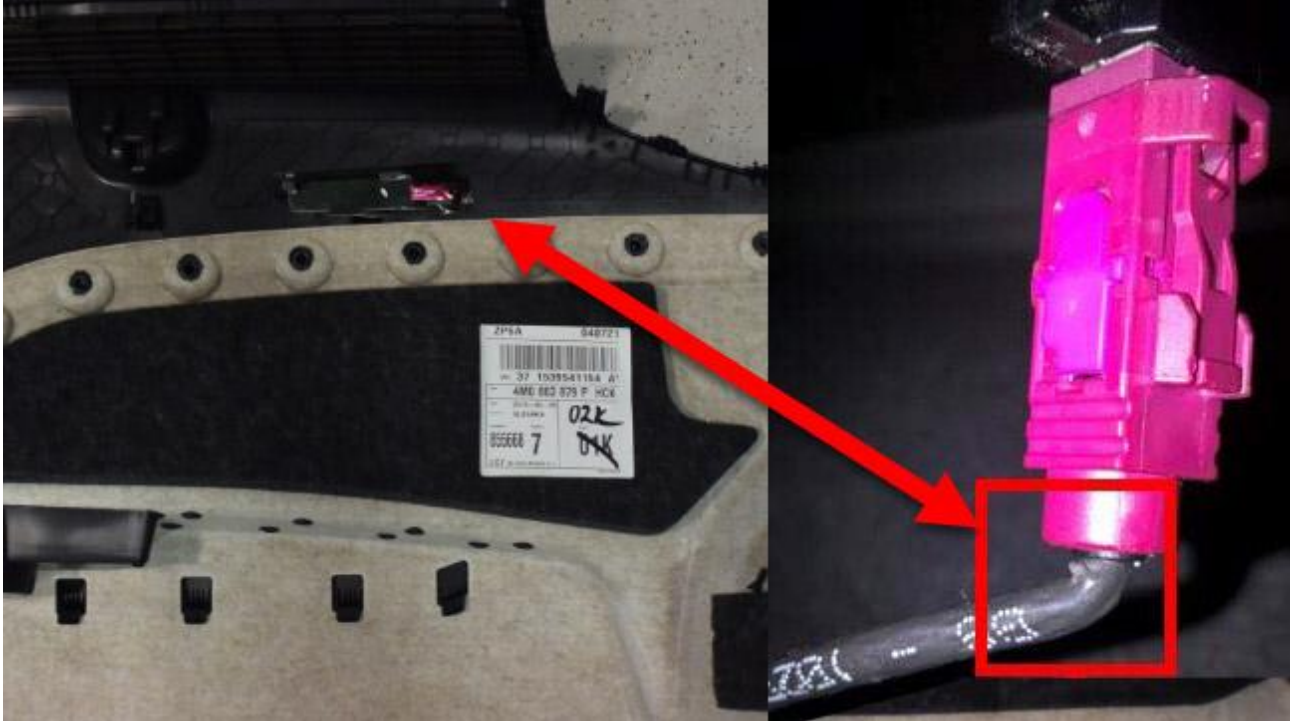
The contact on the wiring of the emergency call aerial may have been damaged in production. This can cause the concern specified above.

- Switch off the ignition
- Remove the left luggage compartment side trim panel according to repair manual.
- Perform a visual inspection of coaxial wiring, if wiring is under tension or kinked (Figure 2), continue with TSB.

**Figure 2.** Coaxial wire kinked at R263 SOS Antenna.

3. Repair existing coaxial harness:

The information in the manual for VAS 6720 on how repairs on the emergency call aerial wires are prohibited does not apply to repairs instructed by a TSB.
