## Technical Service Bulletin

| <b>Topic</b> | 91 SOS warning displayed in instrument cluster, DTCs B105313 and B153313 stored in the data bus diagnostic interface |
| <b>Brand</b> | Audi |
| <b>Transaction No.</b> | 2054630/4 |

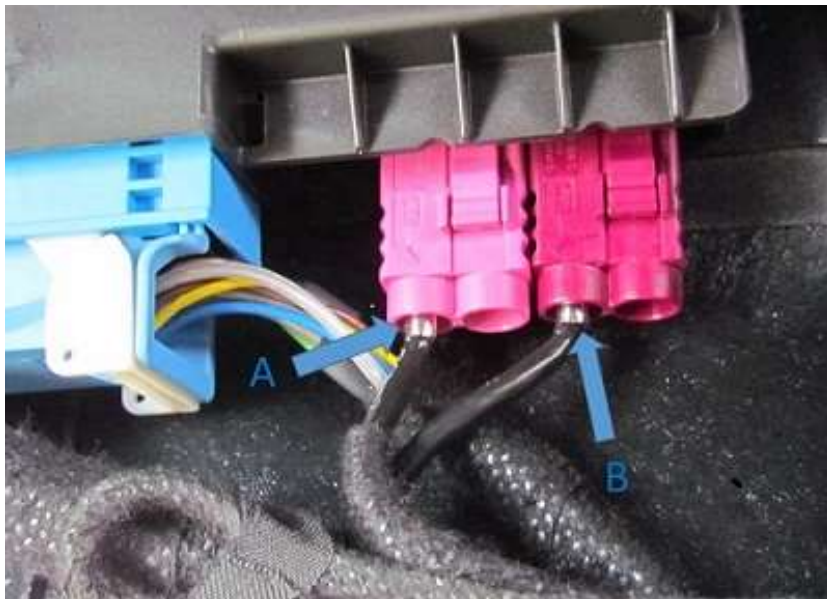
### **Figure 2 shows the connections on the gateway for a vehicle with additional aerial:**

- Arrow **A** shows the connection for the additional emergency call aerial. (PR number: **IW3 or IW5 + 4GR or 4GY**).
- Arrow **B** shows the connection for the aerial in the dash panel. (PR number: **IW3 or IW5**)

**Figure 2.** GSM antenna location reference at the data bus on board diagnostic interface, J533 (address word 0019).

- If the **DTC “B105313 – GSM antenna open circuit”** is logged in vehicles **with or without** an additional aerial, the path must be checked at connection **A**.
- If the **DTC “B153313 – GSM antenna 2 open circuit”** is logged in vehicles **with** an additional aerial, the path must be checked at connection **B**.

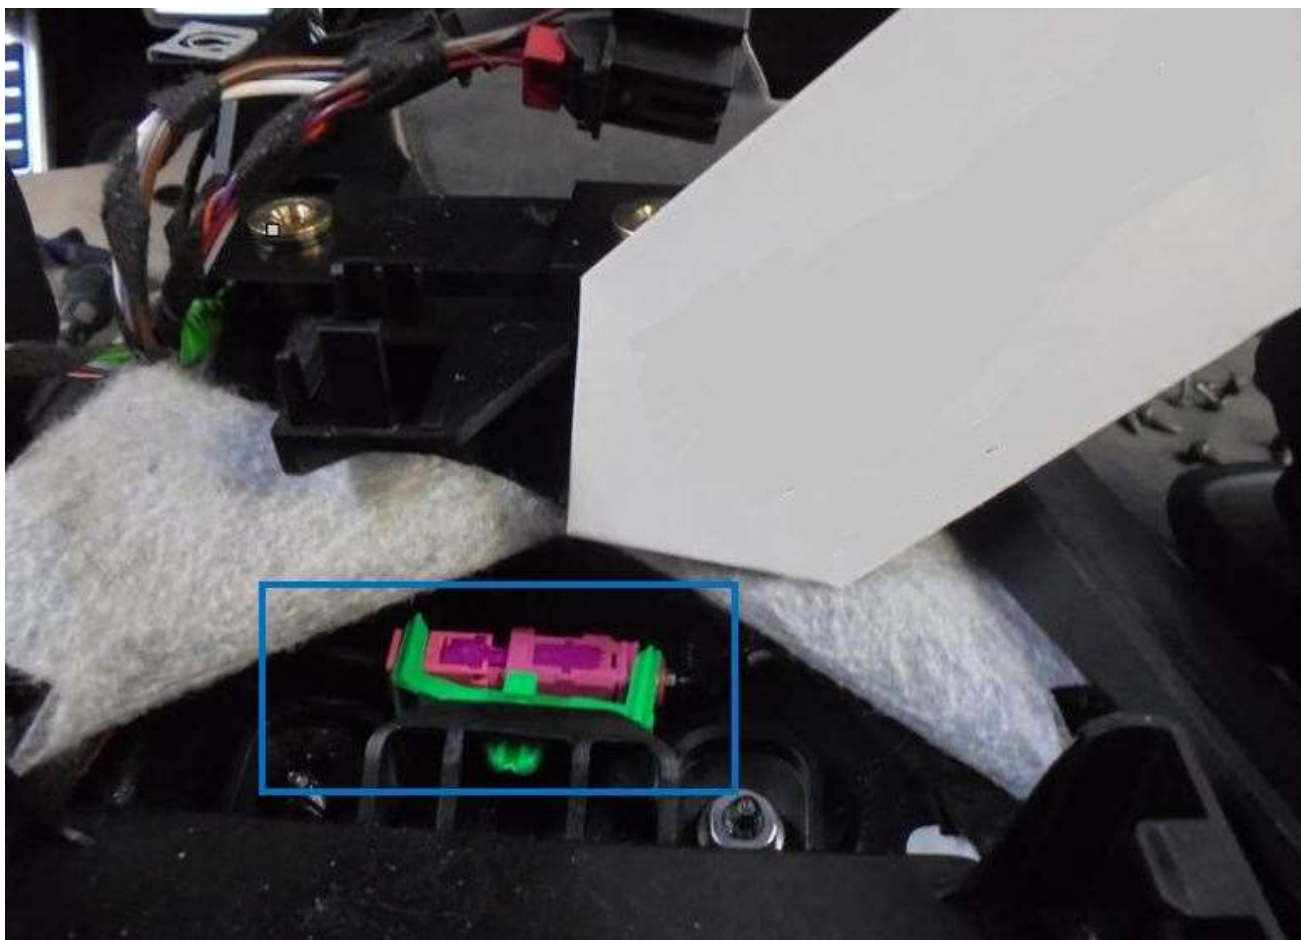
*Figure 3. Loose plug on connector T2dx (see blue frame).*

If the cable is under tension or is kinked, replace both contacts on the connection using VAS 6720; if necessary, extend the cables using VAS 6720.

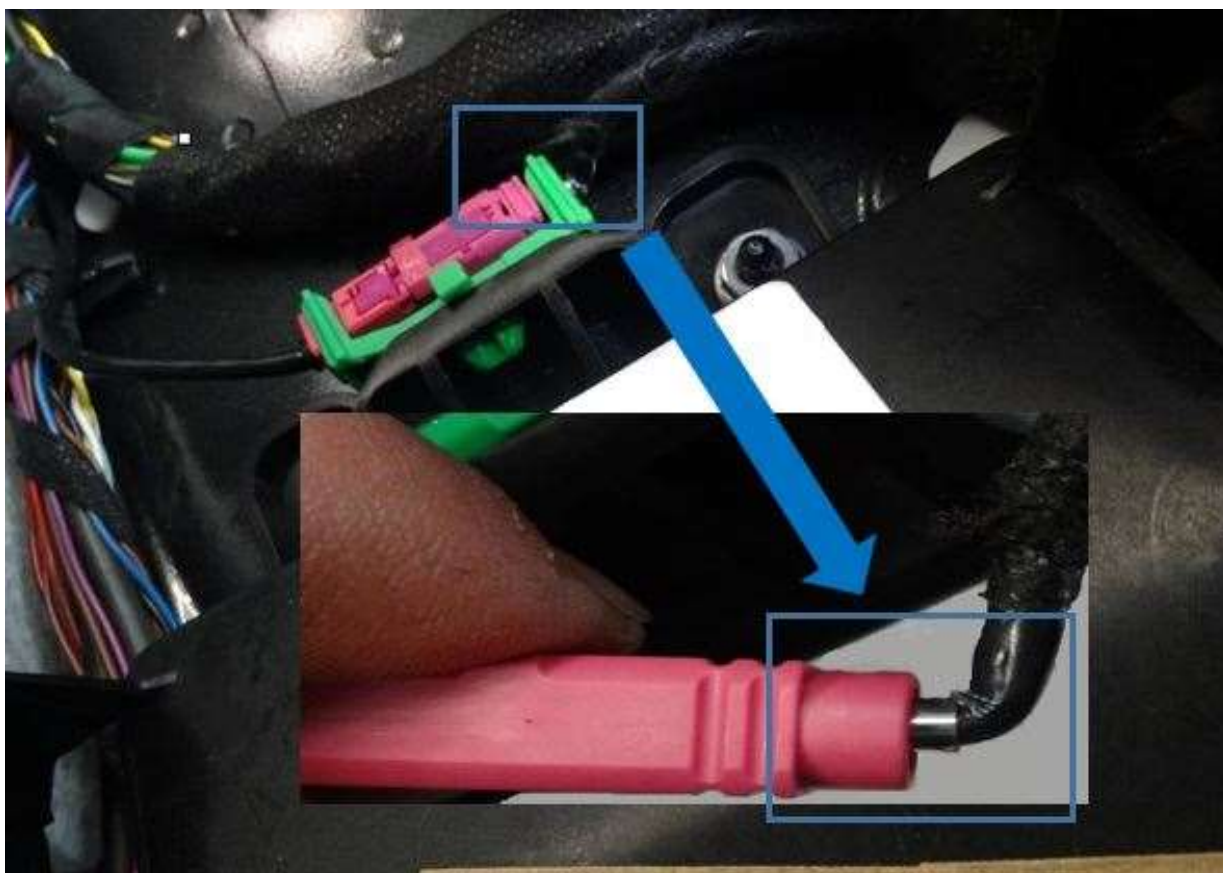
**Figure 4.** Kinked cable on the connector T2dkx (see zoomed in section, blue arrow).
