## Technical Service Bulletin

| <b>Topic</b> | 93 Charging door does not open when button pressed - B1A8FF0, B1A89F0, B1A8AF3, B1A88F3 |
| <b>Brand</b> | Audi |
| <b>Transaction No.</b> | 2071343/2 |

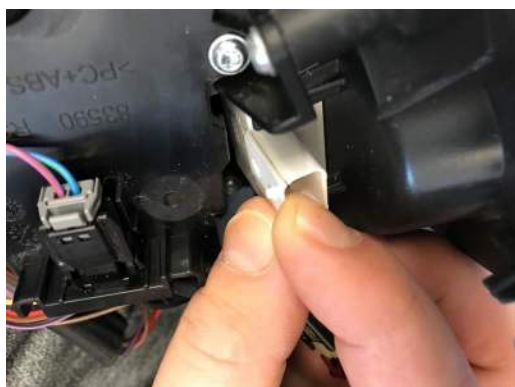
Quality issues in the production process may lead to a crack in the connector point of the charging indicator (Figure 1). Moisture can reach the contact pins in the charging indicator connector via this crack. As a result, a bypass can occur between the ground contact pin and the LIN contact pin. This leads to a communication fault between the components of the charging door and the charging unit for high-voltage battery. In this circumstance, the electric operation of the charging door does not work.

**Figure 1:** Crack in the connector point of the charging indicator.

3. Check the connector point on the charging indicator for cracks (Figure 1).

If the connector point is cracked or the pins are oxidized (Figure 7), replace the damaged charging door unit as described under the heading **“Removing and installing charging door unit”** below.

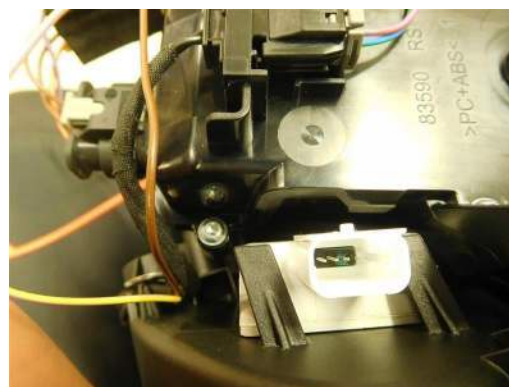
**Figure 2:** Evidence of water intrusion in the charging indicator connector.

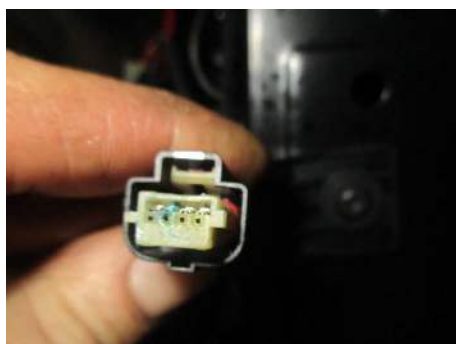
**Figure 3:** Evidence of water intrusion in the connector housing.

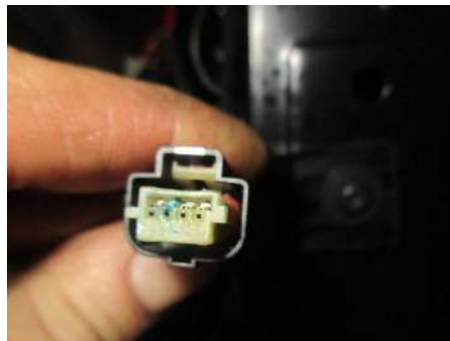
2. Check the contacts on the connector housing and on the charging indicator for oxidation.

**Figure 5:** Oxidation on the connector housing.

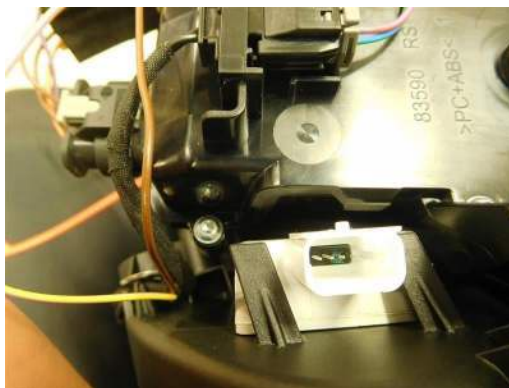
**Figure 7:** Oxidation of the pins on the charging indicator connector.

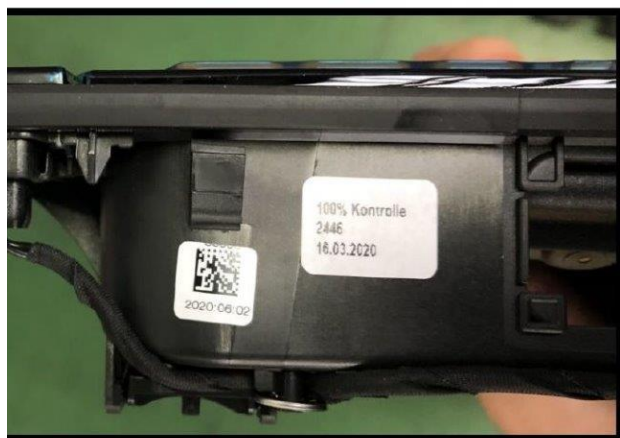
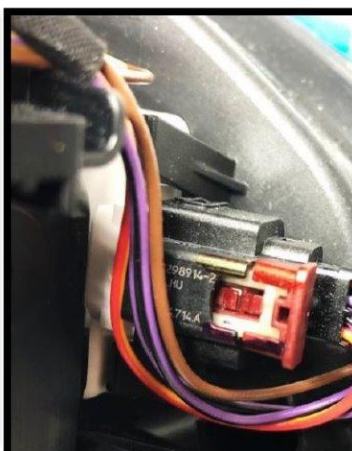
**Figure 8:** The charging indicator connector pictured is the updated part.

4. To avoid the need for repeat repairs, check whether the charging door supplied by the parts department already has a sealed charging indicator connector. This can be identified on the basis of the QR code sticker and the red line on the connector (Figure 8).

If this is not the case, seal the charging indicator connector on the new charging door unit with 1-component adhesive sealant (Part number D 469101A3) as described under the heading **“Sealing charging indicator connector”**.

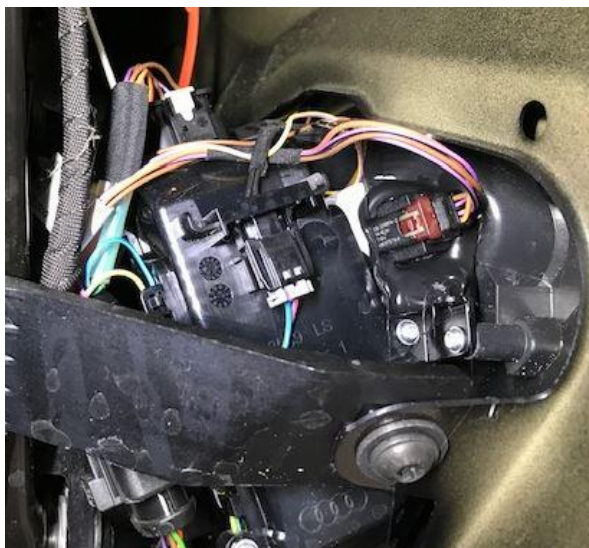
**Figure 24:** The connector should be completely surrounded by the adhesive sealant.

Plug the connector into the charging indicator. The connector should then be completely surrounded by the adhesive sealant (Figure 24).

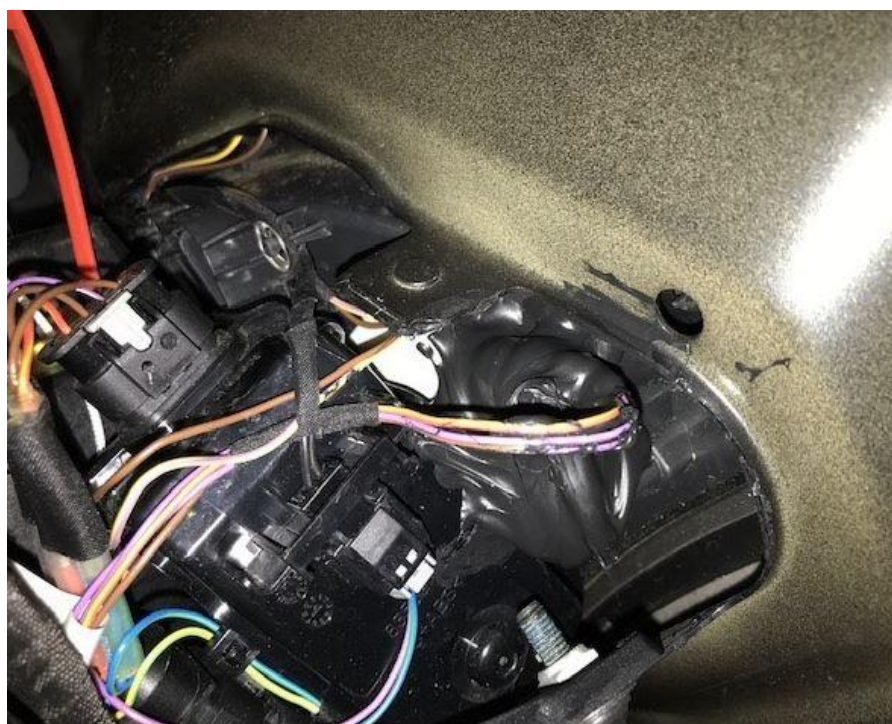
**Figure 25:** The entire connector and the connector point of the charging indicator must be covered with adhesive sealant.

The entire connector and connector point of the charging indicator and parts of the charging indicator must be covered with adhesive sealant to ensure protection against moisture ingress (Figure 25).
