## Technical Service Bulletin

| <b>Topic</b> | 48 Steering and/or electronic damping control yellow lamp on when starting engine B200000, B200FF4,U103100 |
| <b>Brand</b> | Audi |
| <b>Transaction No.</b> | 2074847/5 |

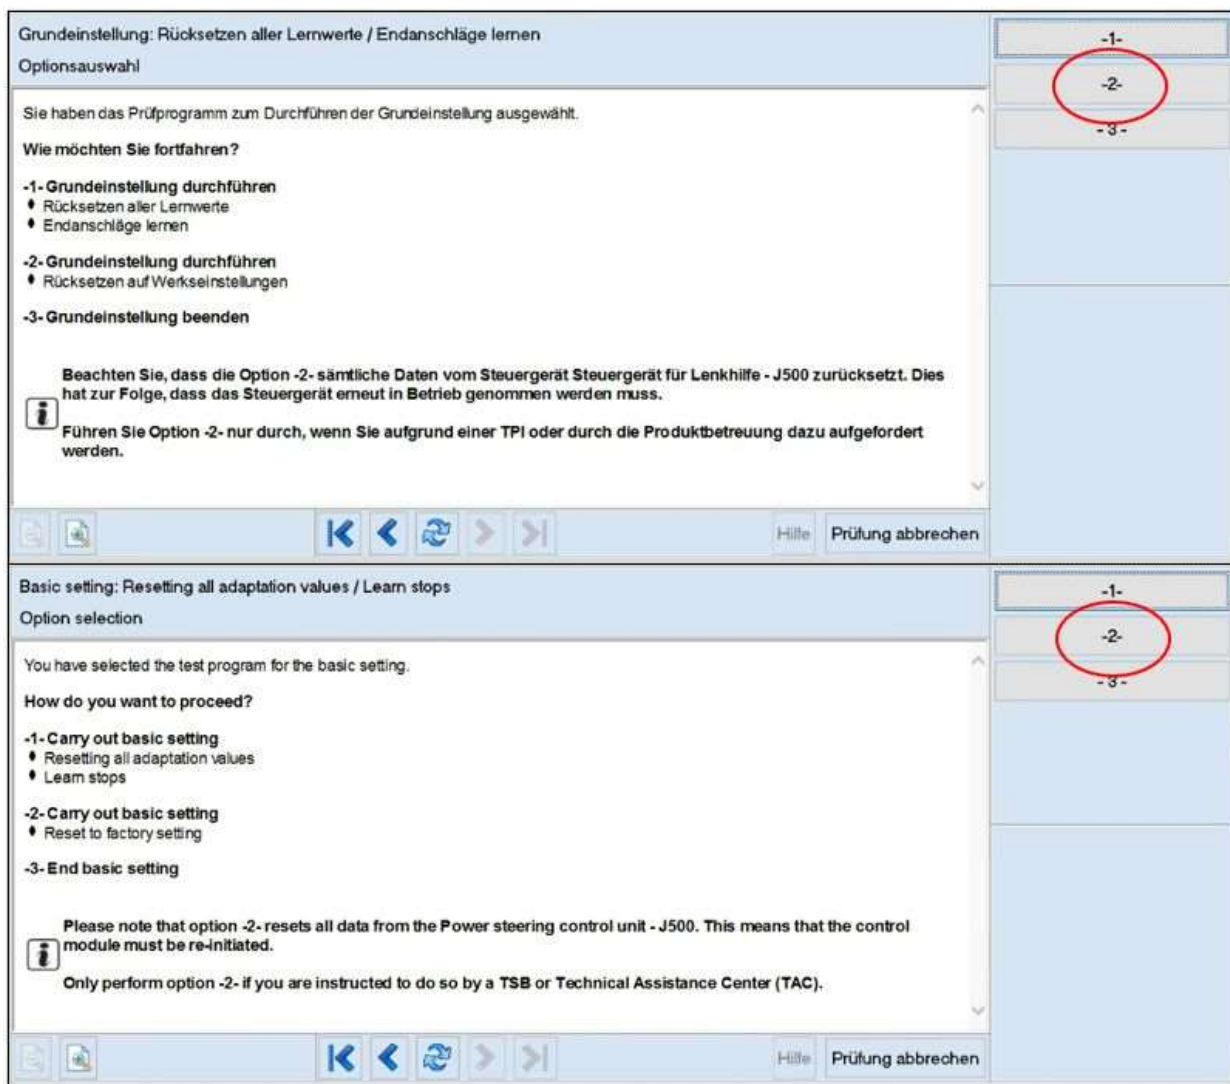
**Figure 1:** J500 factory settings reset – Guided Functions.

- First reset the steering control unit at diagnostic address 0044 (J500) to factory settings via Guided Functions.
- Select option “2” as shown in the picture (Figure 1).

- To do this, go to the basic settings for the test program and use the **login code 1181** for the program “**0044 - Reset all adaptation values / adapt end stops**”.

- The tester may not automatically report that the reset is complete; click on the “Done/Continue” button manually. Afterwards, check whether the coding in control unit J500 (address 0044) under Identification has been set to “00000000000000”.
