## Condition

| Revision Table | | | |
|---|---|---|---|
| 2077251/1 | 03/20/2025 | 21-25-01 | Original publication |

| DTC | Description |
|---|---|
| P2563 | Turbocharger Boost Control Position Sensor Circuit Range/Performance |

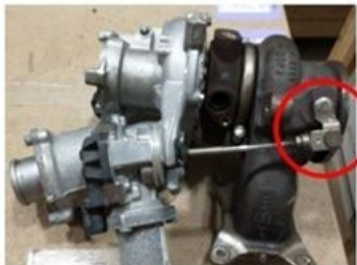
- Check wastegate adjustment on turbocharger (see illustration 1, red circle) for stiffness/secure fit:
  - If the wastegate adjustment moves easily, this TSB does not apply and further diagnosis is needed.
  - If the wastegate adjustment is not easily moved, continue with step 2.

**Illustration 1) wastegate rod (affected area on turbocharger)**

Generously spray wastegate adjustment with commercially available rust remover and let sit for at least 30 minutes.

- With the ODIS tester, attempt to perform basic settings for the wastegate adjustment:
  - If the wastegate adjustment basic settings can be performed successfully, apply grease to the clevis on the wastegate adjustment with hot screw paste (part number G 052 112 A3). No further work is necessary, clear the faults and return the vehicle to the customer.
  - If the wastegate adjustment basic settings cannot be performed with the ODIS tester, continue with “With turbocharger removed”.

- If the repairs are unsuccessful, replace the turbocharger according to the repair manual.
- Apply grease to the new clevis on the wastegate adjustment with hot screw paste (part number G 052 112 A3).
- Perform basic settings using the ODIS tester and clear the faults.
- No further work is necessary, the vehicle can be returned to the customer.
