## Technical Service Bulletin (TSB)

### No Start, Loose Ground

| REFERENCE: | TSB: 08-089-25 REV. A<br>GROUP: 08 - Electrical | Date: | April 1, 2025 | REVISION: | 08-089-25 |
| VEHICLES AFFECTED: | 2024 (GG) Dodge Hornet<br>This bulletin applies to vehicles built on or before June 07, 2024 (MDH 0607XX) equipped with a 2.0L I4 DOHC DI Turbo Engine w/ESS (Sales Code EC1). | | | MARKET APPLICABILITY:<br><div><input checked="" type="checkbox"/> NA<input type="checkbox"/> MEA<br/><input type="checkbox"/> SA<input type="checkbox"/> IAP<br/><input type="checkbox"/> EE<input type="checkbox"/> CH</div> | |

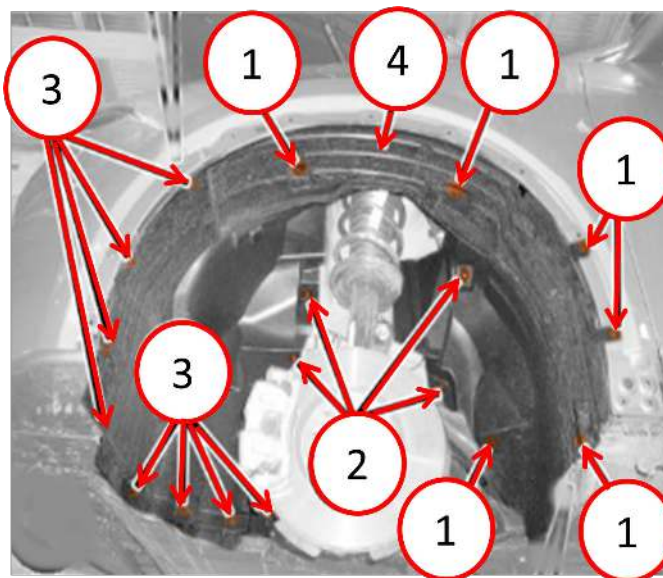
**Fig. 1**

Left Front Splash Shield Fasteners, Nuts And Screws

3. Remove the left front splash shield fasteners, nuts and screws from the splash shield [Fig. 1](#).

5. Install the left front splash shield fasteners, nuts and screws [Fig. 1](#). Tighten all screw and nut fasteners securely.
6. Install the left tire and wheel assembly. Refer to the detailed procedures available in DealerCONNECT > Service Library> under: 22 - Tires and Wheels / Installation.
7. Lower the vehicle.
8. Clear all DTCs that may have been set.

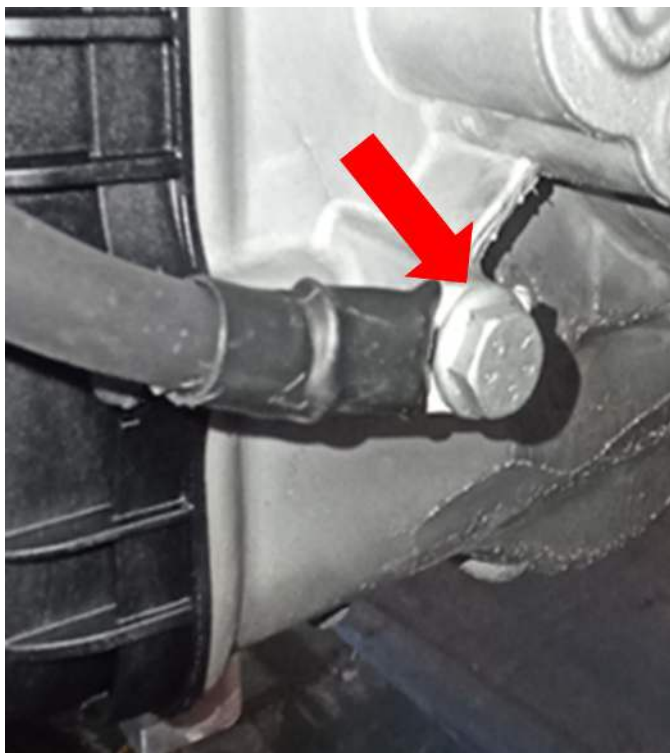
**Fig. 2**  
G902A Ground Bolt

| CAUSE: | Ground issue | | | | |

This bulletin involves replacing the G902A ground bolt.

4. Replace the G902A ground bolt [Fig. 2](#). Tighten the bolt to 15 N·m (11 Ft. Lbs.).
