## Technical Service Bulletin (TSB)

### Camshaft Sensor DTC

| REFERENCE: | TSB: 08-099-25<br>GROUP: 08 - Electrical 09 - Engine | Date: | April 4, 2025 | REVISION: | — |
| VEHICLES AFFECTED: | 2022 - 2023 (JL) Jeep Wrangler<br>2022 - 2023 (JT) Jeep Gladiator<br>This bulletin applies to vehicles equipped with 3.0L V6 Turbo Diesel Engine W/ESS (Sales Code EXJ). | | | MARKET APPLICABILITY:<br><div><input checked="" type="checkbox"/> NA<input type="checkbox"/> MEA<br/><input type="checkbox"/> SA<input type="checkbox"/> IAP<br/><input type="checkbox"/> EE<input type="checkbox"/> CH</div> | |

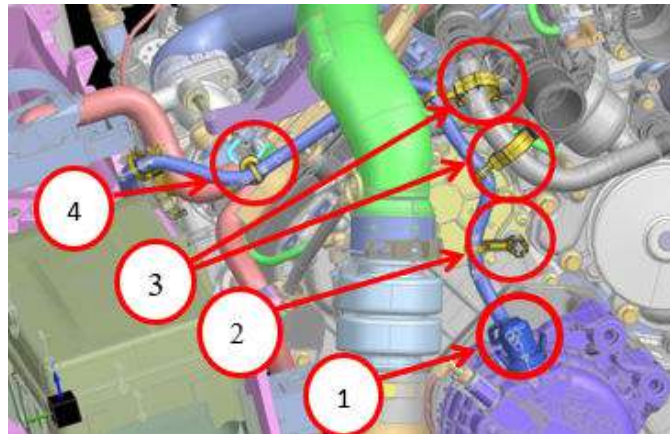
**Fig. 1**  
generator Field Harness

- 1 - Generator B+ Connector
- 2 - Stud Clip
- 3 - C - Clips
- 4 - Fir Tree Clip

1. Disconnect negative battery cable. Refer to the detailed service procedures listed in DealerCONNECT> Service Library> Service Info under: 08 - Electrical / 8F - Engine Systems / Battery System / Standard Procedure.
2. Disconnect battery positive cable from generator [Fig. 1](#).
3. Remove stud clip, two C-Clips and fir tree clip from harness (four clips) [Fig. 1](#).

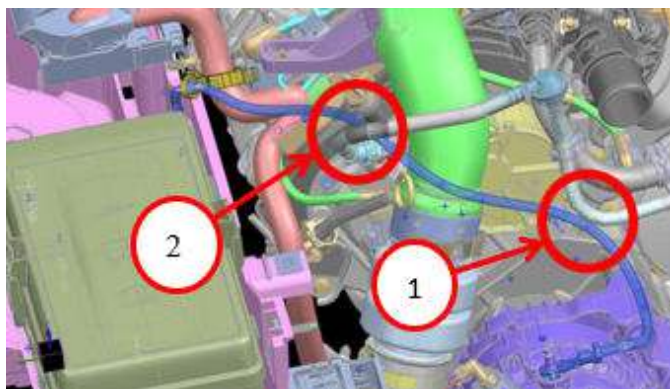
**Fig. 2**  
Re-Routed Harness

1 - Re-routed Harness  
2 - Brake Booster Vacuum Hose

4. Re-route generator positive harness around the Charge Air Cooler (CAC) inlet hose and secure with two tie straps to brake booster vacuum hose [Fig. 2](#).

**NOTE: Ensure harness is not in contact with sharp edges.**

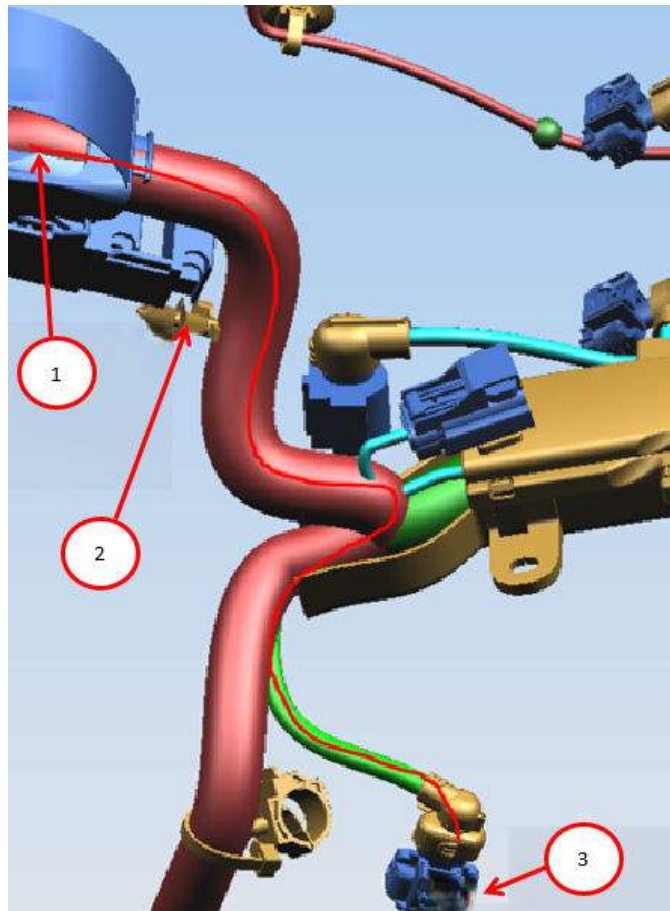
**Fig. 4**  
Cam Sensor Wiring harness

- 1 - PCM C2 Connector
- 2 - Clip Raymond
- 3 - Camshaft Sensor Harness connector

6. Disconnect the Powertrain Control Module (PCM) C2 connector at the PCM.
7. Remove the tie strap on the C2 harness trough [Fig. 4](#).
8. Remove the clip Raymond on C2 harness [Fig. 4](#).
9. Remove the tape on C2 harness [Fig. 4](#).
10. Extract the terminals from the Camshaft Sensor 3W connector [Fig. 4](#).

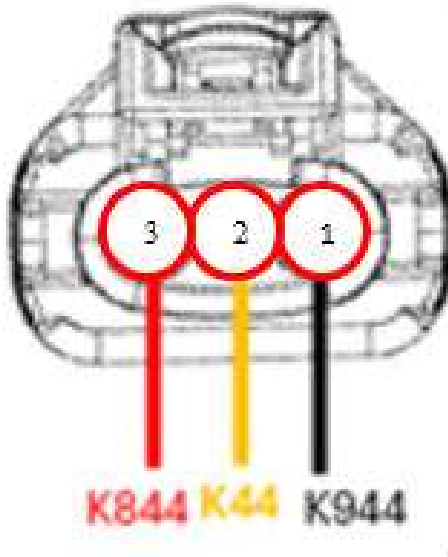
**Fig. 6**  
Camshaft Sensor Harness End

1 - Pin 1  
2 - Pin 2  
3 - Pin 3

13. Strip the wires and solder to the with twisted pair jumper kit using the solder sleeves included in the kit (refer to the kit instructions).
14. Insert kit harness terminals inside the original Camshaft Sensor 3W connector.
15. Tape the harness back up.
16. Fix clip on PCM C2 branch and use a tie strap on the trough to hold the harness within the trough.
17. Reconnect the PCM C2 connector at the PCM.
18. Reconnect the negative battery cable. Refer to the detailed service procedures listed in DealerCONNECT> Service Library> Service Info under: 08 - Electrical / 8F - Engine Systems / Battery System / Standard Procedure.
19. Perform an electrical pin-to-pin test with multimeter to confirm the electrical continuity [Fig. 6](#).

- With ECU connector inserted and KEY-OFF – measure with an ohmmeter set to Ohms.
    - Pin 2 to Pin 1 (SIGNAL Out to SIGNAL/SUPPLY negative) = OL.
    - Pin 2 to Pin 3 (SIGNAL Out to SUPPLY) = OL.
  - With ECU connector inserted and KEY-ON – measure with a voltmeter, at least 100 mV resolution.
    - Pin 2 to Ground (SIGNAL Out) = Around 4.6 V.
    - Pin 3 to Ground (SUPPLY) = 5 V.
    - Pin 1 to Ground (SIGNAL and SUPPLY negative) = 12 V.
20. Turn the key off and reconnect the cam sensor harness connector.
  21. Clear all DTCs that may have been set in any module.
