## Technical Service Bulletin (TSB) Radio USB Software Update to U33.9

| REFERENCE: | TSB: 08-101-25<br>GROUP: 08 - Electrical | Date: | April 4, 2025 | REVISION: | – |
| VEHICLES AFFECTED: | 2024 (RU) Chrysler Pacifica<br>This bulletin applies to vehicles built on or after October 02, 2023 (MDH 1002XX) equipped with: <ul style="list-style-type: none"><li>Uconnect 5 Nav w/10.1" Display (Sales Code UBN).</li><li>Uconnect 5 Nav w/10.1" Display (Sales Code UEN).</li><li>Uconnect 5 w/10.1" Display (Sales Code UBG).</li><li>Uconnect 5 w/10.1" Display (Sales Code UEG).</li></ul> | | | MARKET APPLICABILITY:<br><div><input checked="" type="checkbox"/> NA<input type="checkbox"/> MEA</div> <div><input type="checkbox"/> SA<input type="checkbox"/> IAP</div> <div><input type="checkbox"/> EE<input type="checkbox"/> CH</div> | |

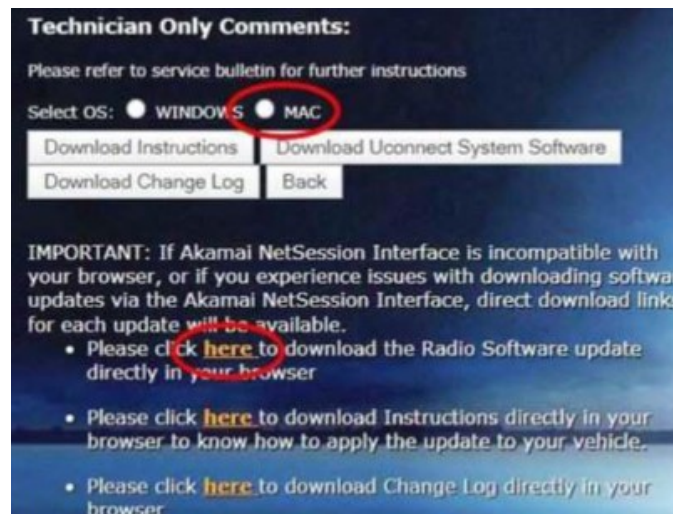
**Fig. 1**

MAC Download Steps

6. Download the software update file to your local PC's desktop. Make sure to select the "MAC" radial button for all downloads [Fig. 1](#).

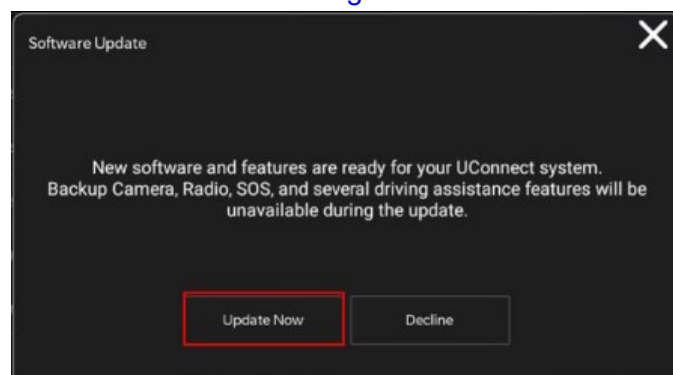
**Fig. 2**

Software Update Is Available

12. Once the system has verified there is an available update, press the "Update Now" button. Make sure the vehicle is in park. Do NOT turn the ignition off until the two minute timer has expired. The ignition doesn't have to be turned off to update the radio's software [Fig. 2](#).

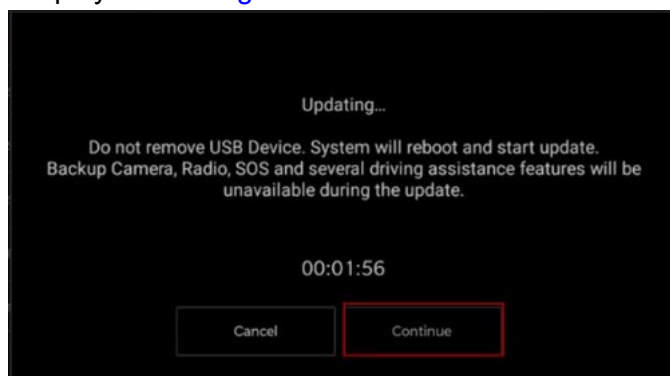
**Fig. 3**

Continue Display Screen

13. Press the “Continue” on the display screen [Fig.3](#).

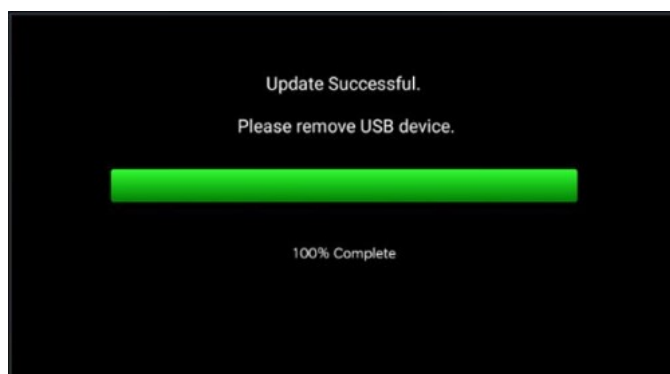
**Fig. 4**

Software Update Completed

14. The radio will reboot and the update will begin. The update should only take 30 minutes [Fig. 4](#).

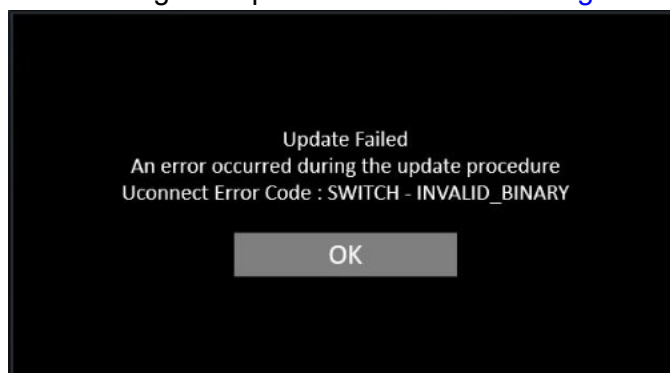
**Fig. 5**

16. Sometimes the radio will display an error pop up “SWITCH- INVALID\_BINARY “ after successful radio update. Please ignore this error message and press “OK” to continue [Fig. 5](#).

Error Message

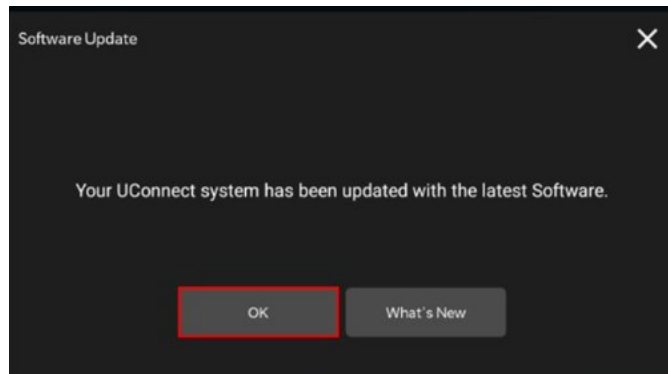
**Fig. 6**

**Radio Software Has Been Updated**

17. Press “OK” to continue [Fig. 6](#).
