## Technical Service Bulletin (TSB)

### Radio U29.28 USB Software Update

| REFERENCE: | TSB: 08-103-25<br>GROUP: 08 - Electrical | Date: | April 5, 2025 | REVISION: | 08-210-23 REV. A |
| VEHICLES AFFECTED: | 2022 - 2023 (RU) Chrysler Pacifica<br>This bulletin applies to vehicles equipped with one of the following: <ul style="list-style-type: none"><li>Uconnect 5 Nav w/10.1" Display (Sales Code UBN).</li><li>Uconnect 5 Nav w/10.1" Display (Sales Code UEN).</li><li>Uconnect 5 w/10.1" Display (Sales Code UBG).</li><li>Uconnect 5 w/10.1" Display (Sales Code UEG).</li></ul> | | | MARKET APPLICABILITY:<br><div><input checked="" type="checkbox"/> NA<input type="checkbox"/> MEA</div> <div><input type="checkbox"/> SA<input type="checkbox"/> IAP</div> <div><input type="checkbox"/> EE<input type="checkbox"/> CH</div> | |

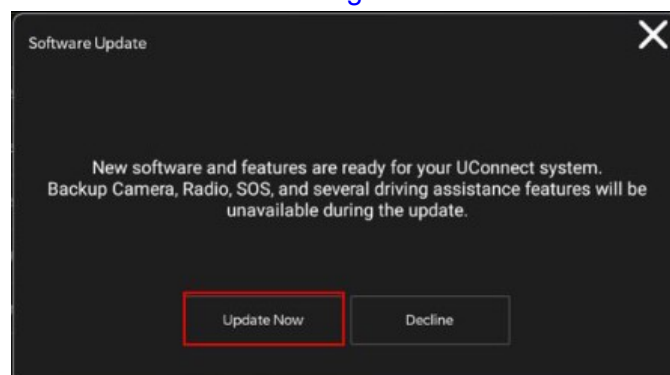
**Fig. 2**

Software Update Is Available

12. Once the system has verified there is an available update, press the "Update Now" button. Make sure the vehicle is in park. Do NOT turn the ignition off until the two minute timer has expired. The ignition doesn't have to be turned off to update the radio's software [Fig. 2](#).

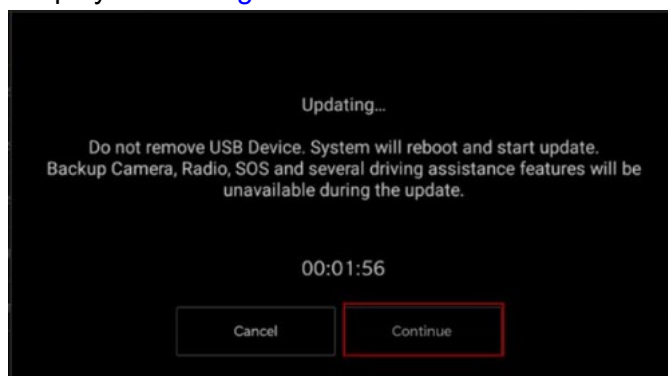
**Fig. 3**

Continue Display Screen

13. Press the “Continue” on the display screen [Fig. 3](#).

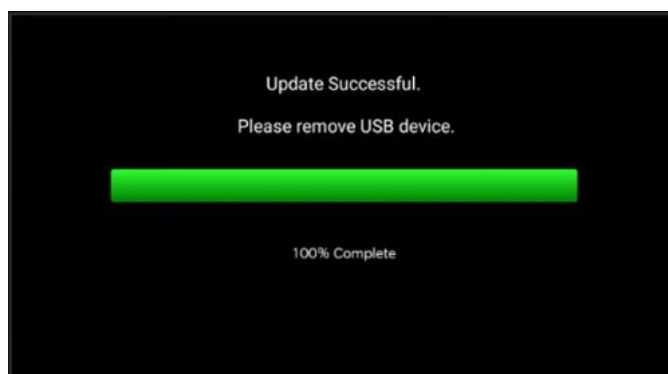
**Fig. 4**

Software Update Completed

14. The radio will reboot and the update will begin. The update should only take 30 minutes [Fig. 4](#).

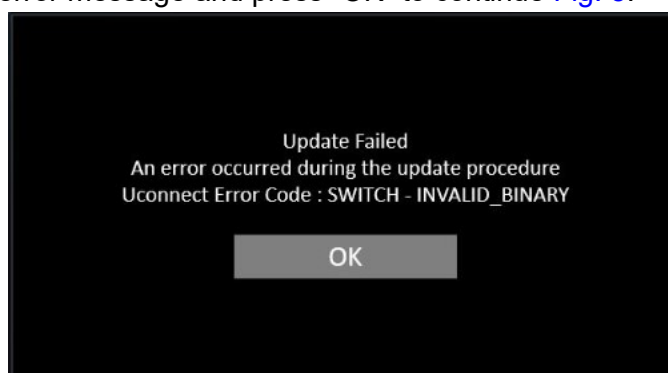
**Fig. 5**

Error Message

15. **Do Not** turn off the ignition at this point. The update is still in process, wait until the radio restarts and the home screen is displayed. This should take around five minutes
16. Sometimes the radio will display an error pop up “SWITCH- INVALID\_BINARY “ after successful radio update. Please ignore this error message and press “OK” to continue [Fig. 5](#).
