# Service Bulletin

Bulletin No.: 23-NA-163

**Subject: No Crank, No Start, Quick Start/Stall, No FOB Detected, Key FOBs Inoperative, B3924 00, B3925 00, B3926 00, B3927 00, B3928 00 Set**

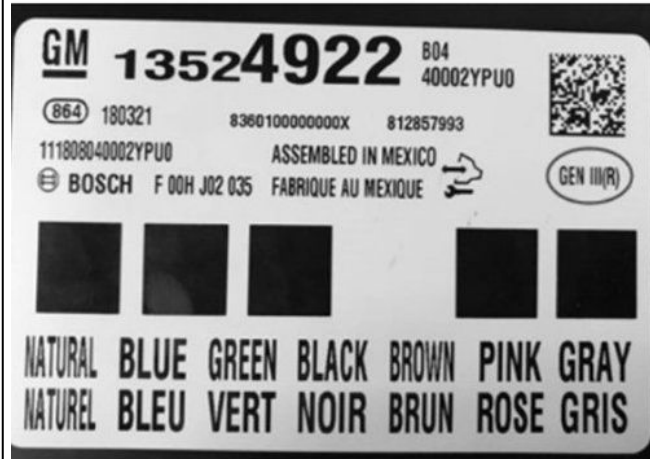
6482605

GEN3R BCMs can be identified by either the label on the module or looking up the BMPN part number information in GDS2.

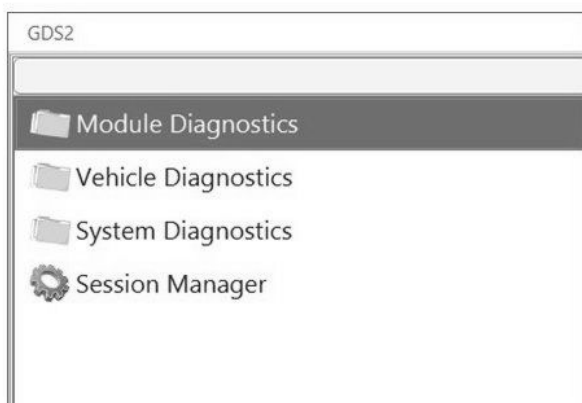
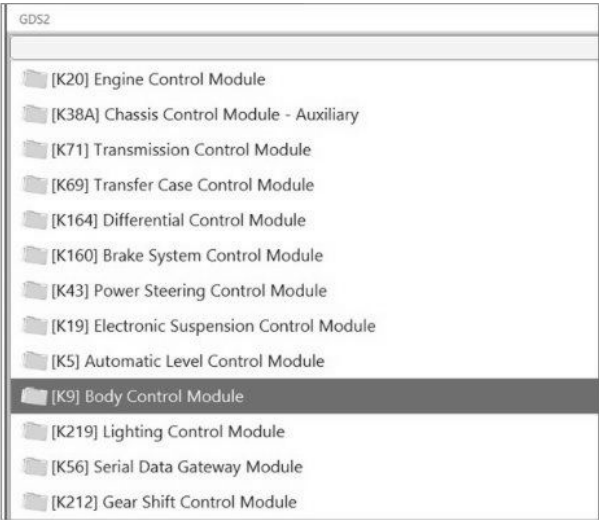
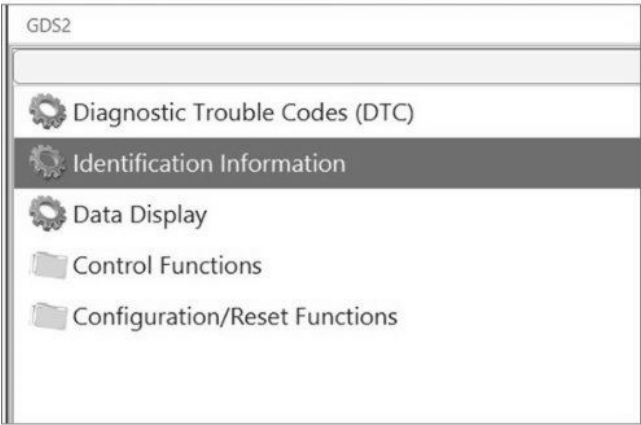
Verify you have a GEN3R BCM Base Model Part Number. Only GEN3R BCMS are eligible for this bulletin. Navigate to GDS2 > Module Diagnostics > [K9] Body Control Module > Identification Information > Identification Information.
