## Technical Service Bulletin

NUMBER  
**25-EV-002H**

MODEL(S)  
**IONIQ 5 (NEA EV)**

**SUBJECT:** HV BATTERY INSPECTION & REPLACEMENT

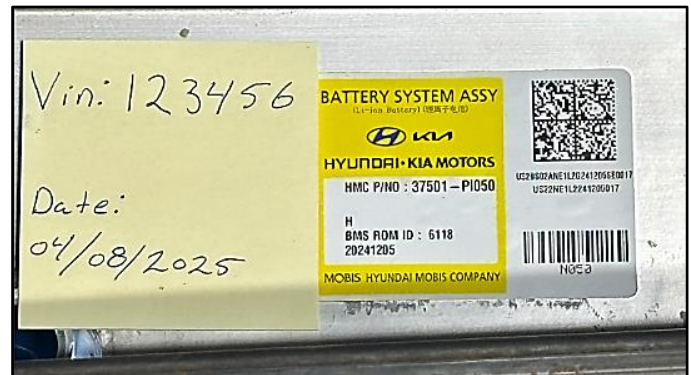
Using STUI, take a photo of the installed BSA's part label with the last 6 digits of the VIN and the date of the repair on a piece of paper.

Upload the photo to STUI.
