## Technical Service Bulletin (TSB) High Voltage Wiring Repair

| REFERENCE: | TSB: 08-082-25 REV. A<br>GROUP: 08 - Electrical | Date: | April 12, 2025 | REVISION: | 08-082-25 |
| VEHICLES AFFECTED: | 2021 - 2024 (JL) Jeep Wrangler<br>This bulletin applies to vehicles equipped with the 2.0L I4 DOHC DI Turbo PHEV Engine (Sales Code ECX) **and China Country Code (Sales Code 8BL)**. | | | MARKET APPLICABILITY:<br><div><input type="checkbox"/> NA<input type="checkbox"/> MEA</div> <div><input type="checkbox"/> SA<input type="checkbox"/> IAP</div> <div><input type="checkbox"/> EE<input checked="" type="checkbox"/> CH</div> | |
| CAUSE: | Water intrusion | | | | |

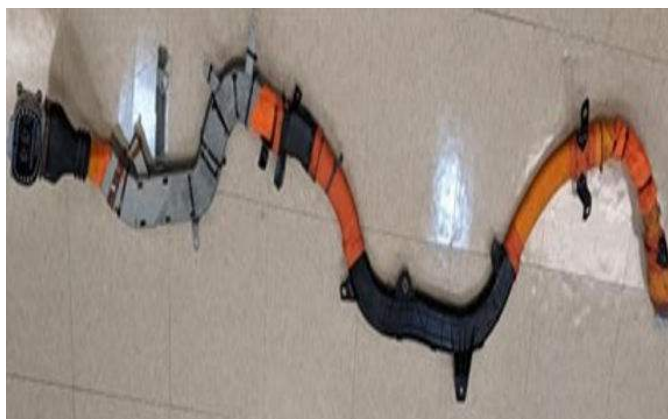
**Fig. 1**  
HV Cable Harness

2. Inspect the PIM to P2 HV cable harness for rub through or damage near the transmission driveshaft CV joint shield.

1. Remove the PIM to Transmission HV cable harness [Fig. 1](#). Refer to the detailed service procedures available in DealerCONNECT/Service Library under: Service Info> 12 - Electrified Powertrain System / High Voltage Battery / Cables / Removal and Installation.

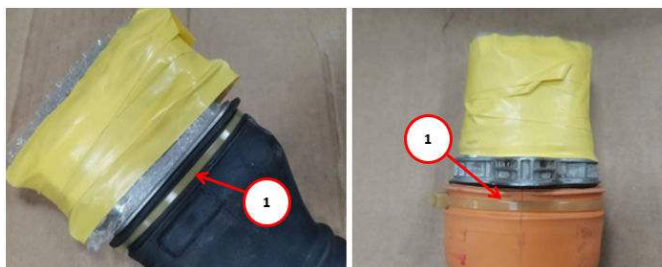
**Fig. 2**  
HV Cable Harness Connectors

1 - HV Cable Harness Connector Zip Ties

3. Is the HV cable harness damaged or rubbed through near the transmission driveshaft CV joint shield?
4.
  - YES>>> Replace the PIM to Transmission HV cable harness. Proceed to [Step 17](#).
  - NO>>> Proceed to [Step 5](#).
5. Using a suitable protective cover and tape, protect both ends of the HV cable harness connectors to prevent dust and contaminants from entry [Fig. 2](#).
6. Remove the plastic zip tie on the HV cable harness connector rubber sleeve [Fig. 2](#).

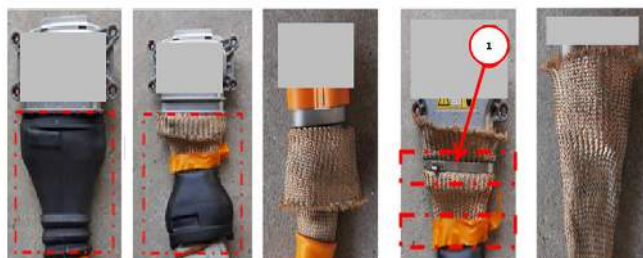
**Fig. 3**  
HV Cable Harness Exposed Metal Mesh Shielding

1 - Metal Clamp

7. Fold the rubber sleeve backward to its maximum position to expose the metal mesh shielding [Fig. 3](#).

8. Remove the tape from the shielding layer and remove the metal clamp, then stretch the mesh shielding layer up forward [Fig. 3](#).
9. Using compressed air, thoroughly clean the shielding layer and the HV wires from contaminants, oxides, and moisture.

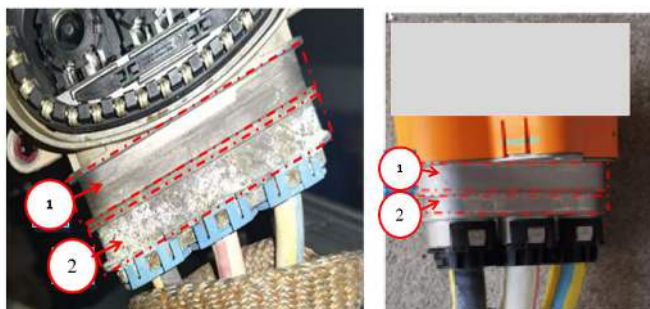
**Fig. 4**  
HV Cable Harness Connector Grooves Exposed

1 - Zone A Groove  
2 - Zone B Groove

10. Fold the shielding layer and HV wires and make maximum exposure of the groove [Fig. 4](#).

11. Use the wire brush to thoroughly clean the HV cable harness connector end of oxidation and dust in Zone A and Zone B [Fig. 4](#).

- Evenly spray ENIENT EC0132 (natural rust remover) on the oxidized and rusted parts of the HV cable harness connector. For hard to reach spots like grooves and gaps with severe rust, use a soft brush dipped in the rust remover to ensure full contact with the oxidized and rusted layer.
- Wait three to five minutes or more for full chelation and dissolution of the oxidation to occur.
- After oxidation dissolution, wipe and clean the surface of the dissolved oxidization and any residual cleaning material. Dry the surface with a soft cloth or towel. **DO NOT** allow this to air dry. An air compressor gun can also be used expedite the drying of the surfaces.

- If the oxidization is too severe and cannot be cleaned, sand polish the groove, (**DO NOT over polish**).
  - Use the air compressor gun to blow away the dust and make the area clean.
12. Put back the metal mesh shielding layer around the HV cable harness connector and use the original metal clamp to secure the connector and shielding layer. Wrap with electrical tape [Fig. 5](#).

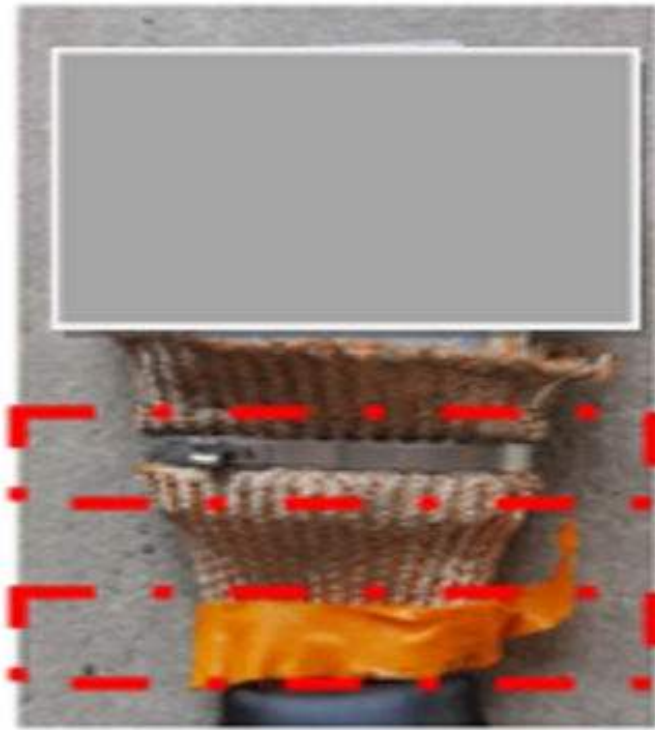
**Fig. 5**

Proper HV Cable Harness Connector Mesh And Clamp Positioning

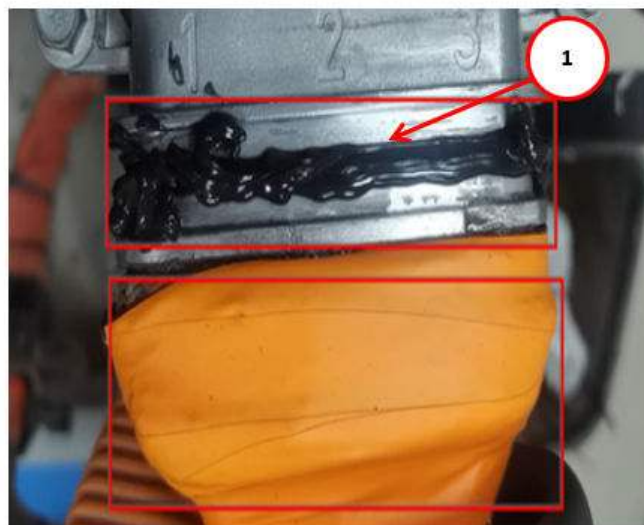
**Fig. 6**

HV Cable Harness Connector Sealed Using Darbond 2598

1 - Sealed HV Cable Harness Connector

13. Apply Darbond 2598 sealing compound evenly around the tightening area between the HV cable harness connector and the rubber sleeve in Zone A [Fig. 4](#) and [Fig. 6](#).

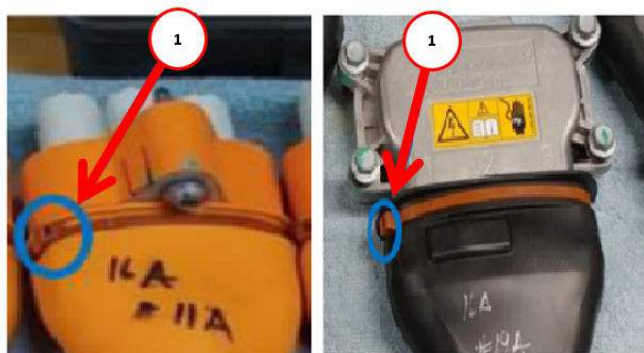
**Fig. 7**

HV Cable Harness Connector Sleeve With Cable Tie

1 - Plastic Cable Tie Position On Connector

14. Reattach the rubber sleeve and secure it within 15 minutes of applying the sealing compound and tighten the plastic cable tie using the HellermannTyton EVO7 tool to 225 N·m (166 Ft. Lbs.). Repeat the same process for the other end connector of the HV cable harness [Fig. 7](#).

**NOTE: Ensure the zip tie head is positioned on the connector side and thoroughly wipe away any excess compound.**
