# Service Bulletin

Bulletin No.: 23-NA-165

**Subject: Vehicle Will Not Lock and Unlock (Loss of Active Functions) Crank or Start (Loss of Passive Functions) with DTC P0513 Set**

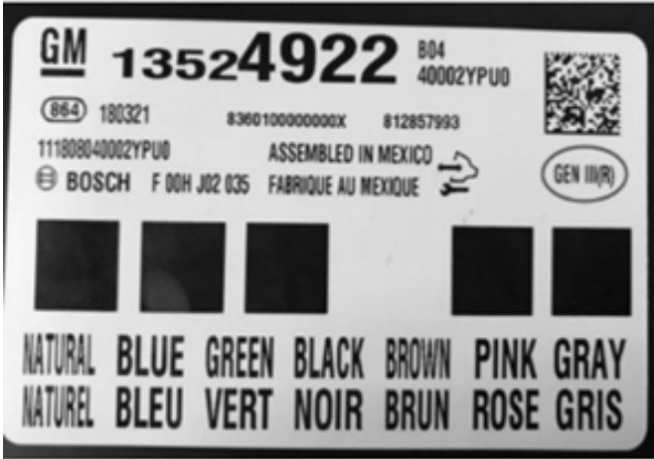
6430397

| Correction | <p><b>Important:</b> Do not attempt the immobilizer procedure or module replacements before following this bulletin.</p> <p><b>This procedure ONLY applies to the GEN3R BCM.</b></p> <p>GEN3R BCMs can be identified by either the label on the module or looking up the BMPN part number information in GDS2.</p> |

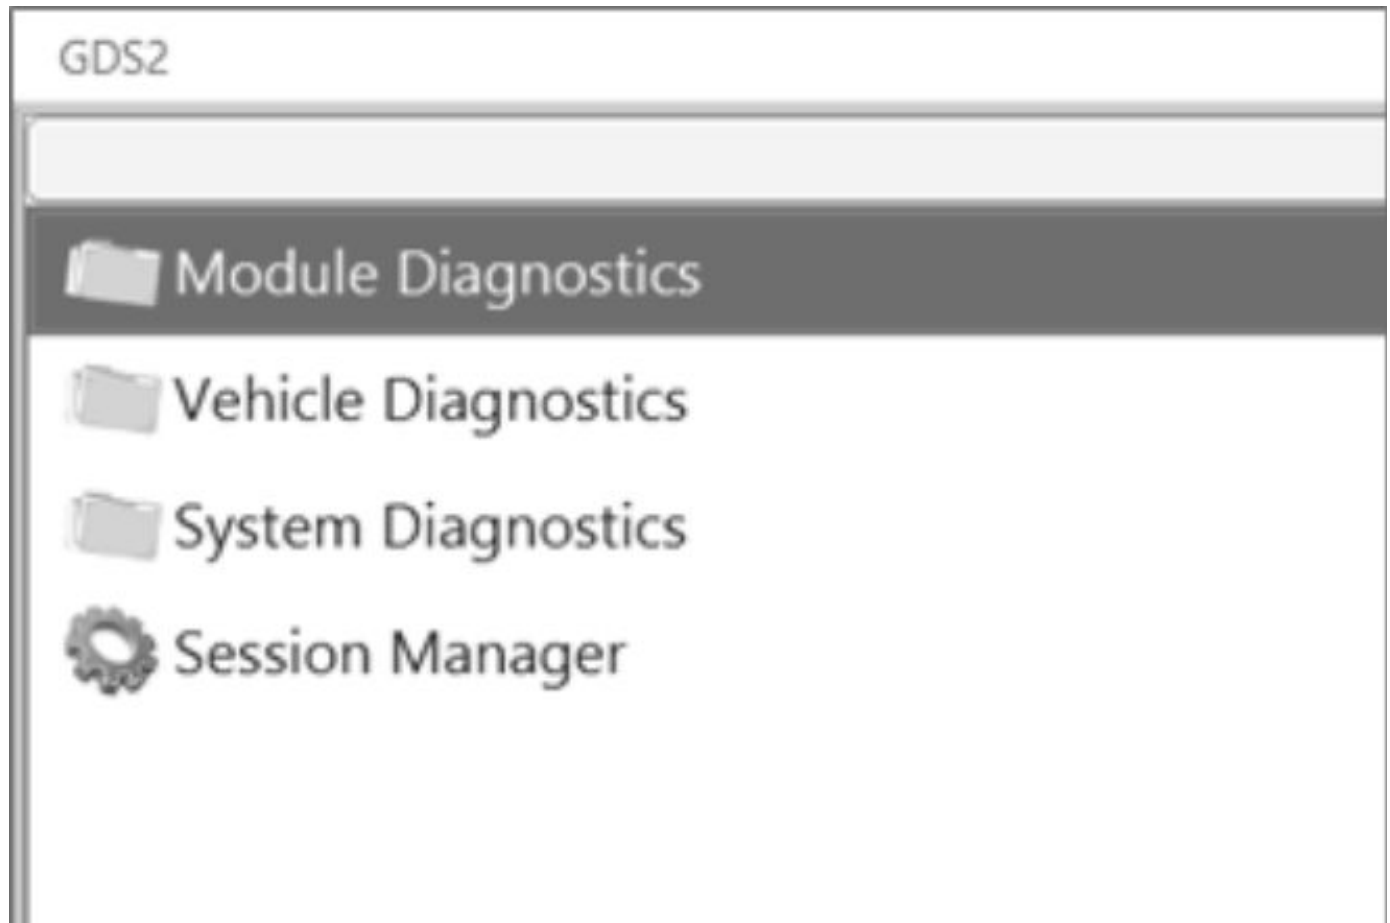
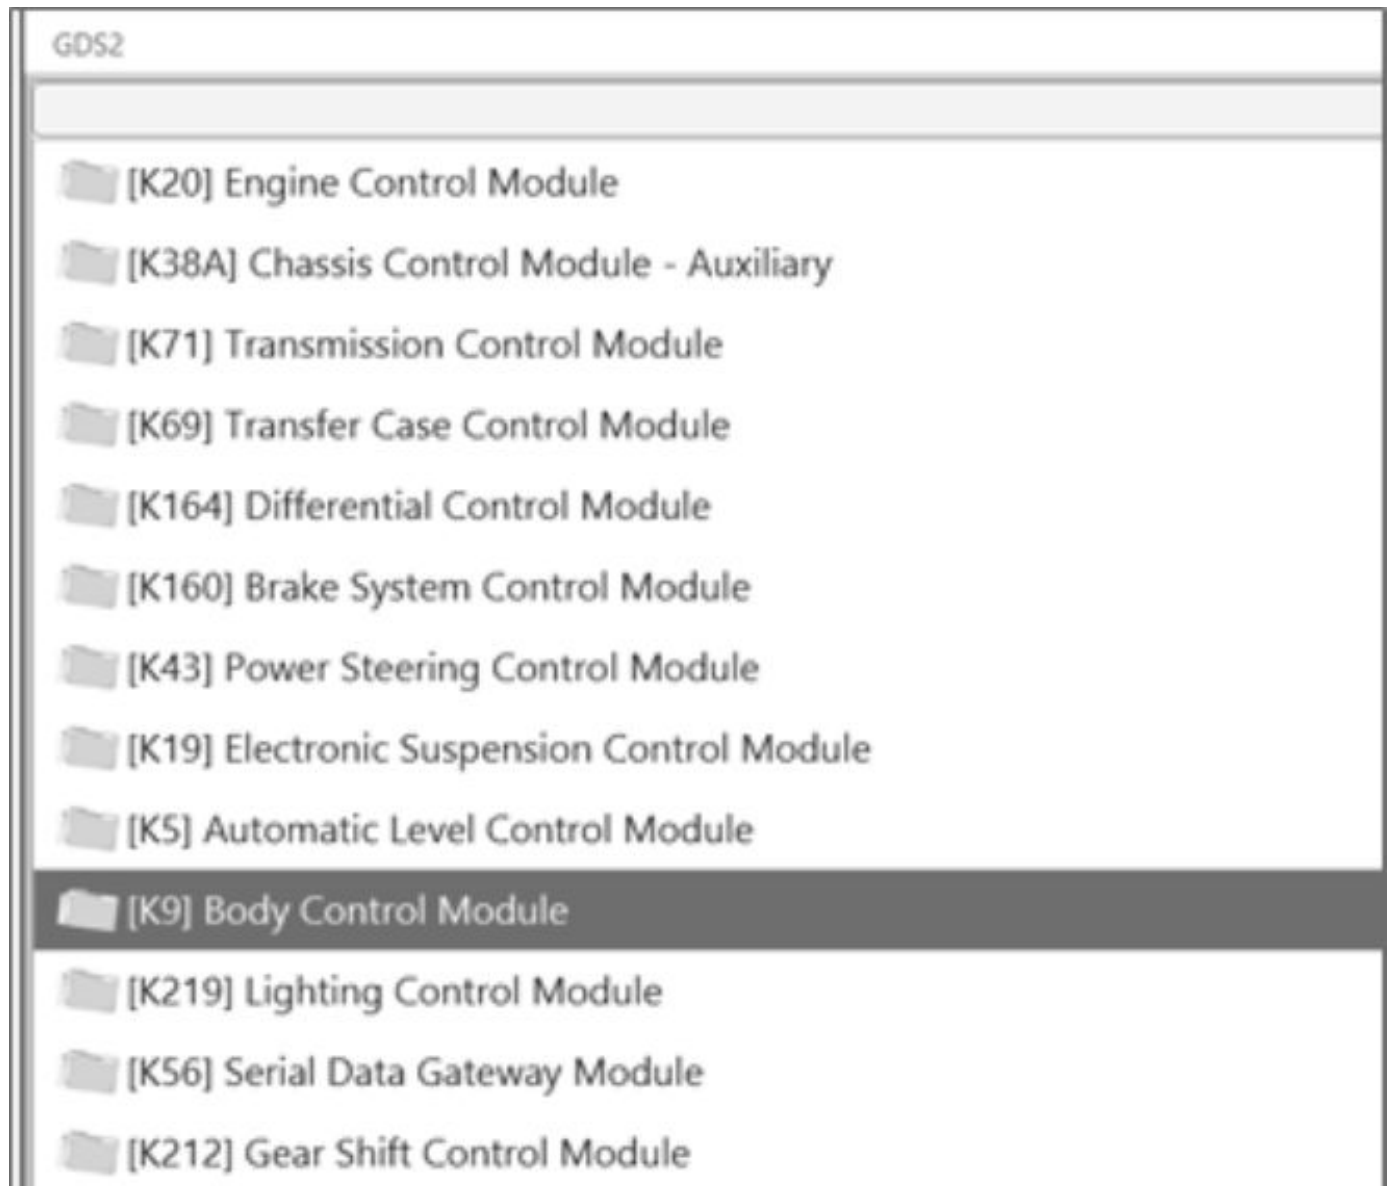
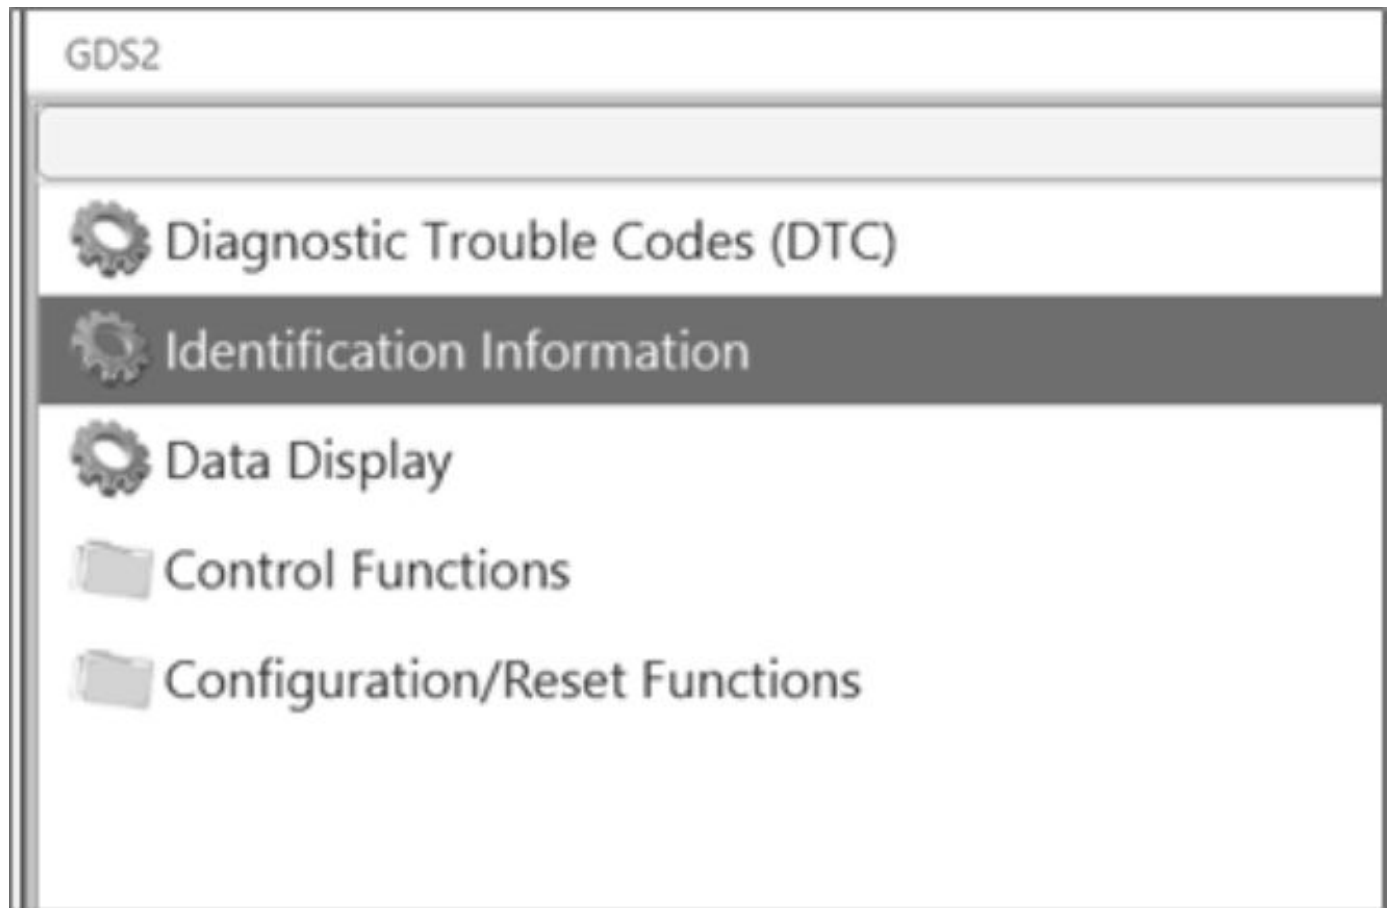
6430394

Verify you have a GEN3R BCM Base Model Part Number. Only GEN3R BCMS are eligible for this bulletin. Navigate to GDS2 > Module Diagnostics > [K9] Body Control Module > Identification Information > Identification Information.

BMPNs eligible for this bulletin: 13518569, 13518570, 13518602, 13518603, 13519619, 13519620, 13519648, 13527252, 13527260, 13527261, 13527297, 13527298, 13527827, 13529492, 13529493, 13533809, 13533813, 13533814, 13533817, 13533821.
