## TECHNICAL SERVICE BULLETIN

### Non-Shelby GT-350 - Various Concerns With The Active Exhaust System

**25-2146**

10 April 2025

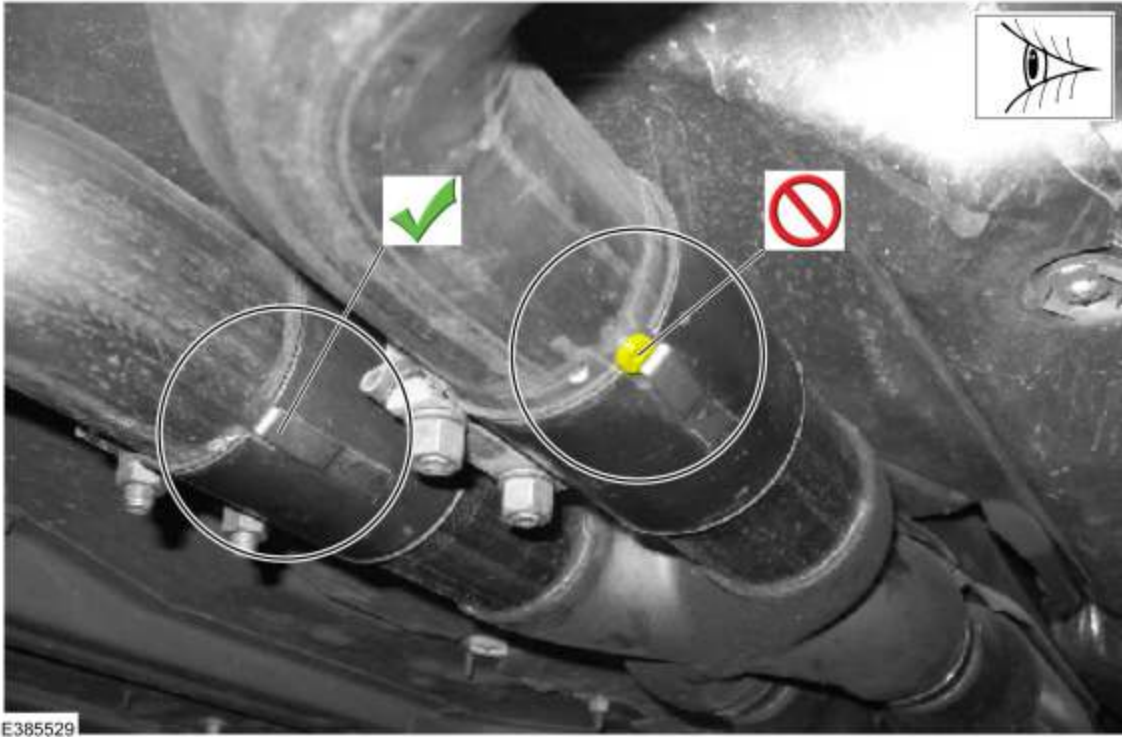
Figure 1 - Exhaust clamp locking tabs.

### 5. Inspect the muffler and tailpipe assembly and both catalytic converters for proper positioning of the exhaust clamps securing them together. Make sure the exhaust clamp locking tab is fully engaged to the catalytic converters (Refer to Figure 1). Make sure the knurled/ridge area of the muffler and tailpipe assembly are covered

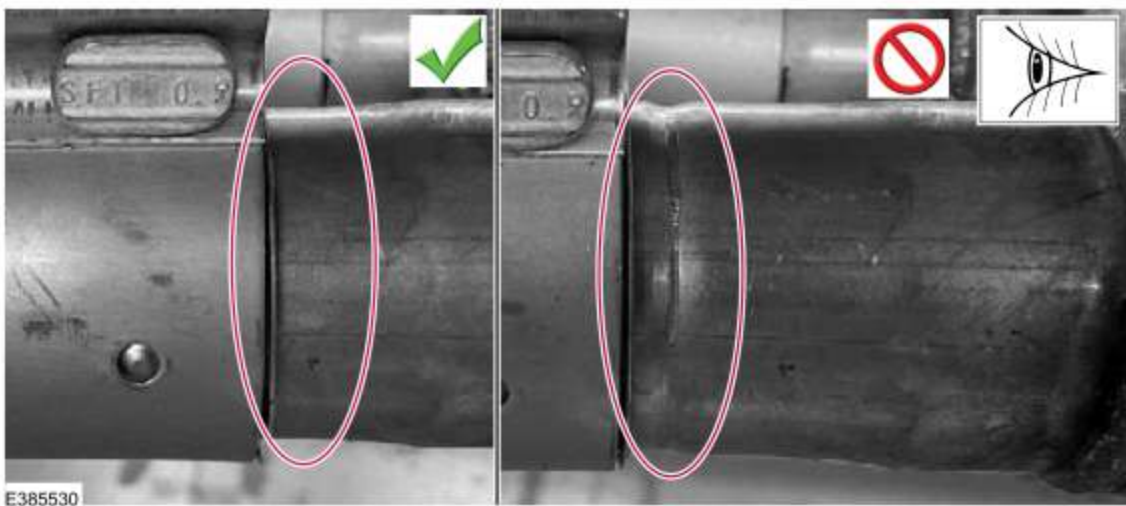
Figure 2 - Non-GT500 exhaust with ridge.

by the exhaust clamps (Refer to Figures 2-3). Adjustments can be made by loosening the exhaust clamps and repositioning the muffler and tailpipe assembly. (Figures 1-3)

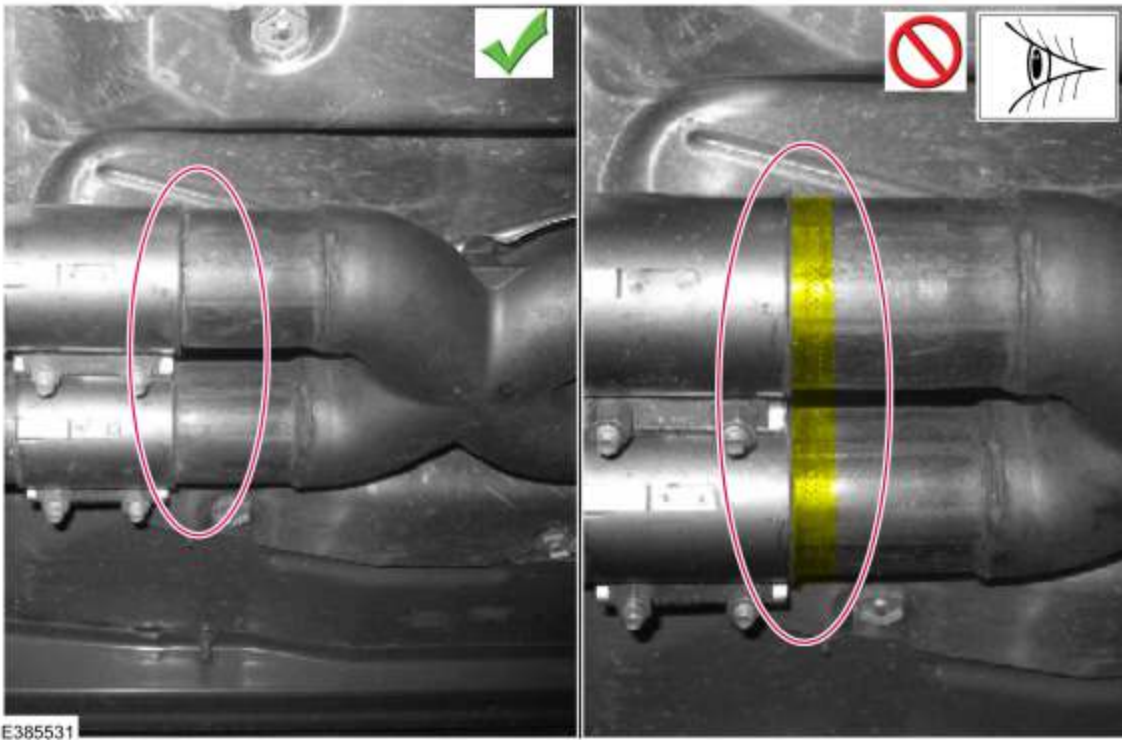
Figure 3 - GT500 exhaust with knurled area.
