# Service Bulletin

Bulletin No.: 25-NA-042

**Subject: ECM Calibration Update for P2BAA**

| Brand: | Model: | Model Year: | | VIN: | | Engine: | Transmission : |
|---|---|---|---|---|---|---|---|
| Chevrolet | Silverado 4500HD/<br>5500HD/6500HD | 2023 | 2023 | | | L5D | |

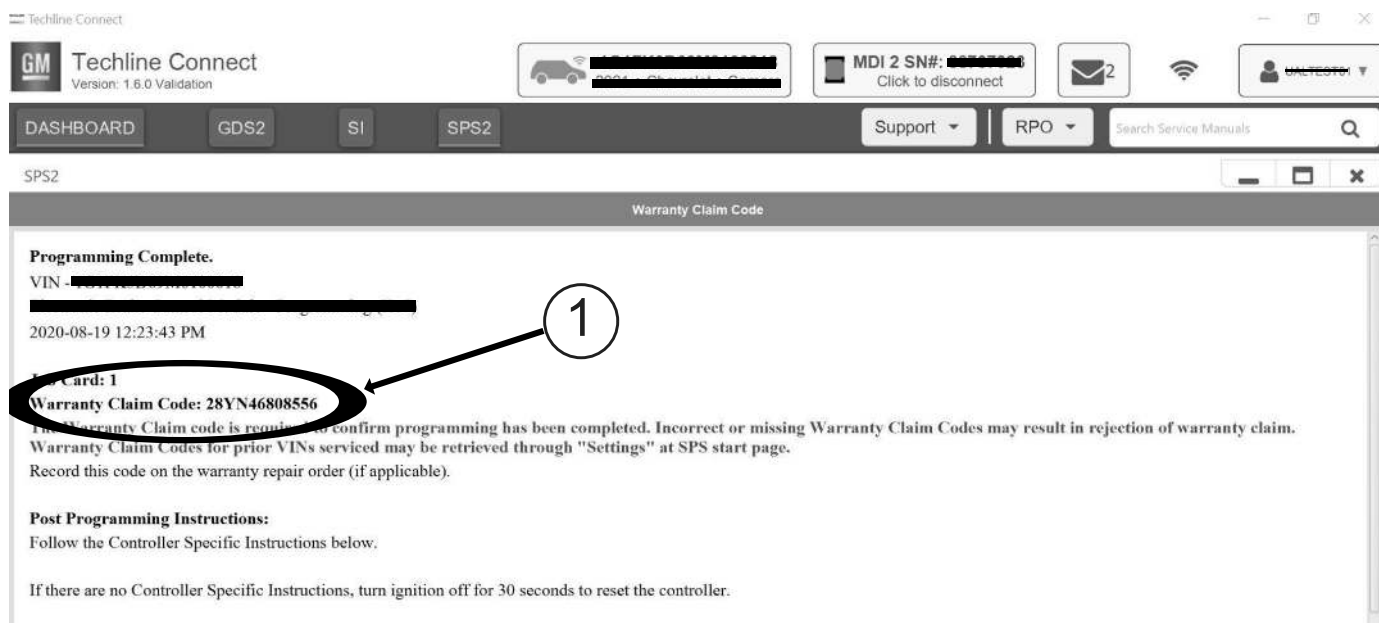
5644478

**Note:** The screenshot above is an example of module programming and may not be indicative of the specific module that is being programmed. Module selection and VIN information have been blacked out.

**Important:** To avoid warranty transaction rejections, you **MUST** record the warranty claim code provided on the Warranty Claim Code (WCC) screen shown above on the job card. Refer to callout 1 above for the location of the WCC on the screen.

- Record SPS Warranty Claim Code on job card for warranty transaction submission.
