## Technical Service Bulletin (TSB)

### A/C Blowing Warm Air

| REFERENCE: | TSB: 08-122-25<br>GROUP: 08 - Electrical | Date: | April 18, 2025 | REVISION: | — |
| VEHICLES AFFECTED: | 2022 - 2024 (WL) Jeep Grand Cherokee/Grand Cherokee L<br>This bulletin applies to vehicles equipped with the 2.0L I4 DOHC DI Turbo PHEV Engine (Sales Code ECX). | | | MARKET APPLICABILITY:<br><div><input checked="" type="checkbox"/> NA<input type="checkbox"/> MEA</div> <div><input type="checkbox"/> SA<input type="checkbox"/> IAP</div> <div><input type="checkbox"/> EE<input type="checkbox"/> CH</div> | |

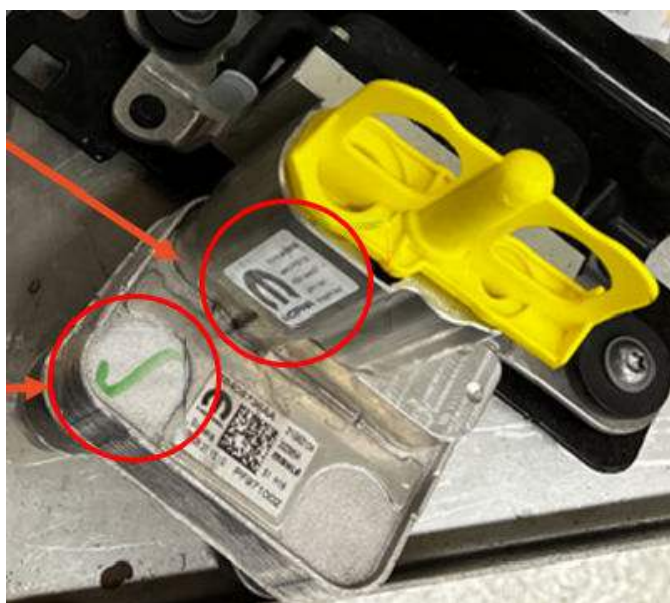
**Fig. 1**

1. Open the hood and check the chiller for part numbers 68470822AA or 68470822AB, then look for any green check marks [Fig. 1](#).
2. Are there part numbers 68470822AA or 68470822AB and any green check marks on the chiller [Fig. 1](#)?
  - YES>>> Proceed to [Step 3](#).
  - NO>>> This bulletin does not apply. This bulletin does not apply.

Chiller With Green Check Mark And Part Number Location

3. Replace the battery chiller. Refer to the detailed service procedures listed in DealerCONNECT>Service Library>Service Info under: 12 - Electrified Powertrain System / Battery Cooling / Chiller / Removal and Installation.
4. **For model years 2022 and 2023 only**, install wire harness jumper 68510660AA.
5. Clear any DTCs.
6. Fast charge the vehicle and drive for 16 km (10 mi) and confirm DTC is cleared.
