## Technical Service Bulletin (TSB)

### A/C Blowing Warm Air

| REFERENCE: | TSB: 08-122-25 REV. A<br>GROUP: 08 - Electrical | Date: | April 23, 2025 | REVISION: | 08-122-25 |
| VEHICLES AFFECTED: | 2022 - 2024 (WL) Jeep Grand Cherokee/Grand Cherokee L<br>This bulletin applies to vehicles equipped with the 2.0L I4 DOHC DI Turbo PHEV Engine (Sales Code ECX). | | | MARKET APPLICABILITY:<br><div><input checked="" type="checkbox"/> NA<input type="checkbox"/> MEA<br/><input type="checkbox"/> SA<input type="checkbox"/> IAP<br/><input type="checkbox"/> EE<input type="checkbox"/> CH</div> | |

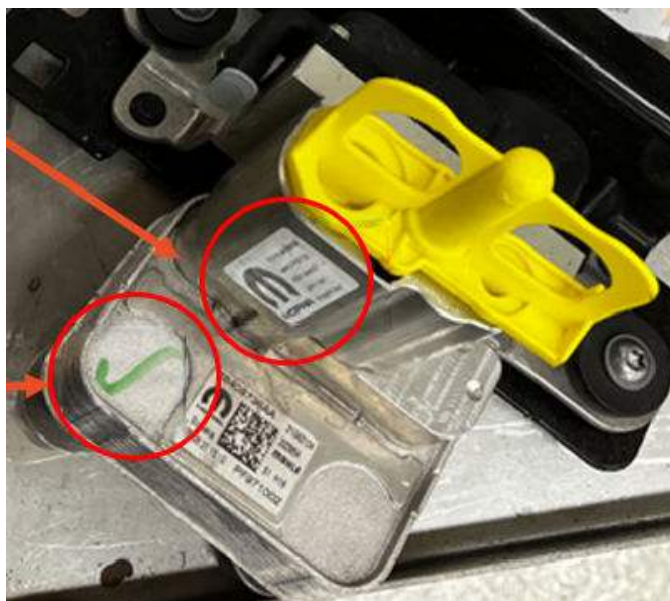
**Fig. 1**  
Chiller With Green Check Mark And Part Number Location

1. Open the hood and check the chiller for part numbers 68470822AA or 68470822AB, then look for any green check marks [Fig. 1](#).
2. Are there part numbers 68470822AA or 68470822AB and any green check marks on the chiller [Fig. 1](#)?
  - YES >>> Proceed to [Step 3](#).
  - NO >>> This bulletin does not apply. This bulletin does not apply.

3. Replace the battery chiller. Refer to the detailed service procedures listed in DealerCONNECT>Service Library>Service Info under: 12 - Electrified Powertrain System / Battery Cooling / Chiller / Removal and Installation.
4. **For model years 2022 and 2023 only**, install wire harness jumper 68510660AA.
5. Clear any DTCs.
6. Fast charge the vehicle and drive for 16 km (10 mi) and confirm DTC is cleared.
