## SERVICE BULLETIN

**APPLICABILITY:** 2015-21MY WRX/STI 2.5L Turbo MT

**NUMBER:** 09-131-25

**SUBJECT:** Diagnosis Procedures for DTCs P2404 & P0420

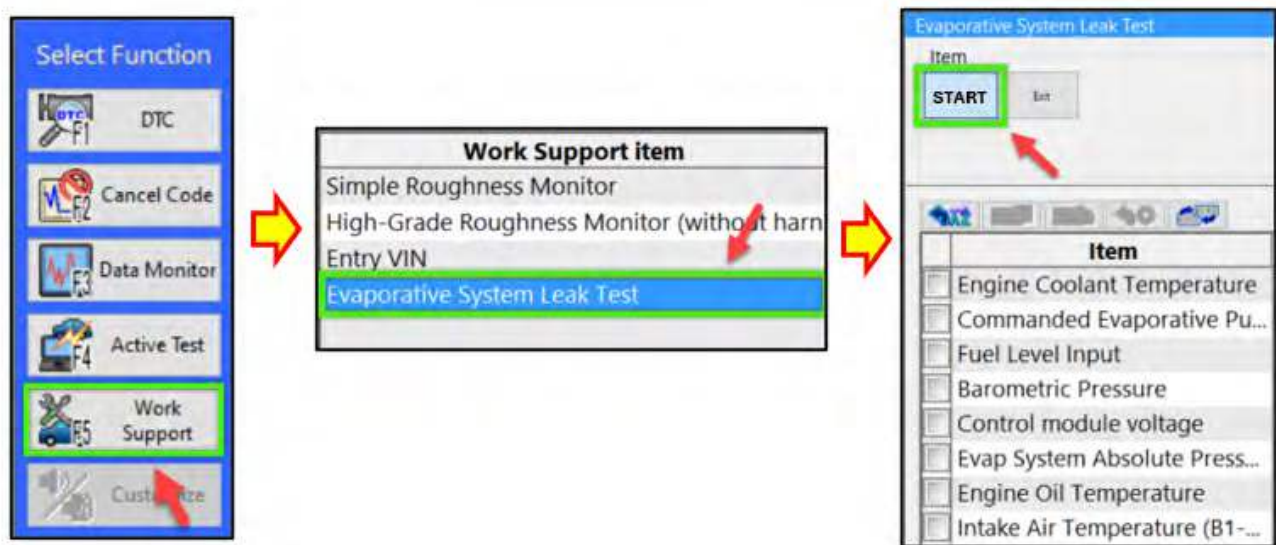
Once the evaporative system leak test is complete, check the DTCs and examine the vacuum value results. Record the value shown in the row labeled MID: \$3C, TID: \$C4, and Scaling ID: \$FE. This value should be lower than -0.26 PSI.

Value Must Be Lower  
Than -0.26 PSI

**STEP 4:** Connect the vehicle to a recommended power supply. See APPENDIX A for addition information regarding power supply. Using SSM, perform the Evaporative System Leak Test. Collect and save all data.
